Access Compliance Report
Public Rights-of-Way
(Curb Ramps)

Intersection ID: 10033082	Main Street: NORTH_REA_PARK_LN	Cross Street: N/A	Location: S
ADA ID: BD18DC8D8638	Ramp Type: Perp	Initial Pass/Fail: Fail	Overall Compliance: No	Severity Score: 12.5

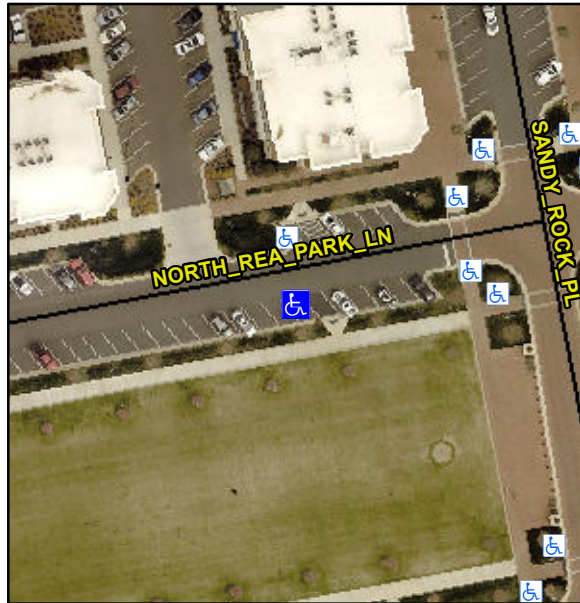
Not Found, R304.2.2

Compliance	Description	Data	Compliance	Description	Data
N/A	Ramp Length (in)	95.0	No	Ramp Slope (%)	11.3
Yes	Ramp Width (in)	59.5	Yes	Ramp XSlope (%)	1.6
N/A	Flare Type LT	N/A	N/A	Flare Type RT	N/A
N/A	Flare Slope LT (%)	N/A	N/A	Flare Slope RT (%)	N/A
N/A	Flare Traversable LT?	N/A	N/A	Flare Traversable RT?	N/A
N/A	Landing Length (in)	N/A	N/A	DWS Provided?	N/A
N/A	Landing Width (in)	N/A	N/A	DWS Contrast?	N/A
N/A	Landing Slope (%)	N/A	N/A	DWS Length (in)	N/A
N/A	Landing X Slope (%)	N/A	N/A	DWS Full Width?	N/A
N/A	Landing Curb? (Y/N)	N/A	N/A	DWS Offset (in)	N/A
N/A	Shared Landing?	N/A			
N/A	Gutter Ponding?	N/A	N/A	Gutter Slope (%)	N/A
N/A	Gutter Lip Ht (in)	N/A	N/A	Gutter X Slope (%)	N/A
N/A	Painted X Walk1?	No	N/A	Painted X Walk2?	N/A
	X Walk 1 Direction	To N		X Walk 2 Direction	N/A
N/A	X Walk 1 Width (in)	N/A	N/A	X Walk 2 Width (in)	N/A
	X Walk 1 Slope (%)	6.7		X Walk 2 Slope (%)	N/A
	X Walk 1 X Slope (%)	0.8		X Walk 2 X Slope (%)	N/A

Remove & Replace Entire Ramp.
