Access Compliance Report
Public Rights-of-Way
(Curb Ramps)

Intersection ID: 26427	Main Street: BALLINARD_LN	Cross Street: ENCLAVE_PL	Location:	SW
ADA ID: BD9B2982C96F	Ramp Type: PerpDiag	Initial Pass/Fail: Fail	Overall Compliance: No	Severity Score: 13.75

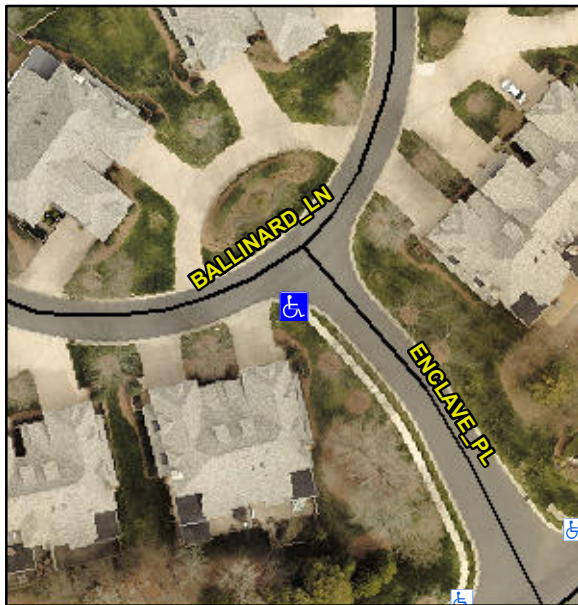
Not Found, R304.2.2, R304.5.3

Compliance	Description	Data	Compliance	Description	Data
N/A	Ramp Length (in)	35.0	No	Ramp Slope (%)	9.2
Yes	Ramp Width (in)	48.0	No	Ramp XSlope (%)	2.6
N/A	Flare Type LT	N/A	N/A	Flare Type RT	N/A
N/A	Flare Slope LT (%)	N/A	N/A	Flare Slope RT (%)	N/A
N/A	Flare Traversable LT?	N/A	N/A	Flare Traversable RT?	N/A
N/A	Landing Length (in)	N/A	N/A	DWS Provided?	N/A
N/A	Landing Width (in)	N/A	N/A	DWS Contrast?	N/A
N/A	Landing Slope (%)	N/A	N/A	DWS Length (in)	N/A
N/A	Landing X Slope (%)	N/A	N/A	DWS Full Width?	N/A
N/A	Landing Curb? (Y/N)	N/A	N/A	DWS Offset (in)	N/A
N/A	Shared Landing?	N/A			
N/A	Gutter Ponding?	N/A	N/A	Gutter Slope (%)	N/A
N/A	Gutter Lip Ht (in)	N/A	N/A	Gutter X Slope (%)	N/A
N/A	Painted X Walk1?	No	N/A	Painted X Walk2?	No
	X Walk 1 Direction	To NE		X Walk 2 Direction	To N
N/A	X Walk 1 Width (in)	N/A	N/A	X Walk 2 Width (in)	N/A
	X Walk 1 Slope (%)	5.6		X Walk 2 Slope (%)	6.2
	X Walk 1 X Slope (%)	4.1		X Walk 2 X Slope (%)	3.1

N/A	Ramp inside XWalk1?	N/A	N/A	Ramp inside XWalk2?	N/A
	Road Slope (%)	1.5	N/A	Clear Space?	N/A
	Road X Slope (%)	6.3	N/A	Clear Space to XWalk (in)	N/A
N/A	Any Obstructions?	N/A	N/A	Storm Grate/Utility Hazard?	N/A
	Obstruction Type			Storm Grate/Utility Type	
N/A					N/A
			Yes	Surface Condition? (G/P)	Good

Remove & Replace Curb Ramp With Two New Directional Ramps or Equivalent.
