# Access Compliance Report
Public Rights-of-Way
(Curb Ramps)

Intersection ID: 2771	Main Street: MAYAPPLE_LN	Cross Street: RIDGEFIELD_DR	Location:	N
ADA ID: BE061552604F	Ramp Type: Perp	Initial Pass/Fail: Fail	Overall Compliance: No	Severity Score: 35

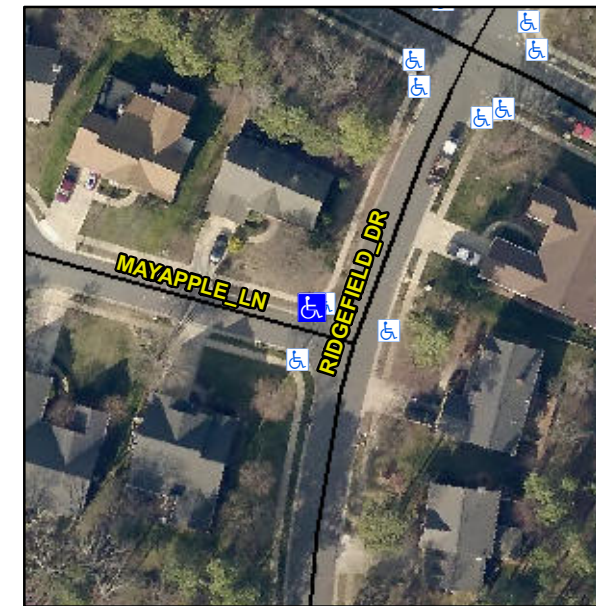
R304.5.1, R304.2.2, R304.5.3

Compliance	Description	Data	Compliance	Description	Data
N/A	Ramp Length (in)	44.0	No	Ramp Slope (%)	12.2
No	Ramp Width (in)	39.0	No	Ramp XSlope (%)	3.2
N/A	Flare Type LT	N/A	N/A	Flare Type RT	N/A
N/A	Flare Slope LT (%)	N/A	N/A	Flare Slope RT (%)	N/A
N/A	Flare Traversable LT?	N/A	N/A	Flare Traversable RT?	N/A
N/A	Landing Length (in)	N/A	N/A	DWS Provided?	N/A
N/A	Landing Width (in)	N/A	N/A	DWS Contrast?	N/A
N/A	Landing Slope (%)	N/A	N/A	DWS Length (in)	N/A
N/A	Landing X Slope (%)	N/A	N/A	DWS Full Width?	N/A
N/A	Landing Curb? (Y/N)	N/A	N/A	DWS Offset (in)	N/A
N/A	Shared Landing?	N/A			
N/A	Gutter Ponding?	N/A	N/A	Gutter Slope (%)	N/A
N/A	Gutter Lip Ht (in)	N/A	N/A	Gutter X Slope (%)	N/A
N/A	Painted X Walk1?	No	N/A	Painted X Walk2?	N/A
	X Walk 1 Direction	To SW		X Walk 2 Direction	N/A
N/A	X Walk 1 Width (in)	N/A	N/A	X Walk 2 Width (in)	N/A
	X Walk 1 Slope (%)	0.4		X Walk 2 Slope (%)	N/A
	X Walk 1 X Slope (%)	3.1		X Walk 2 X Slope (%)	N/A

Remove & Replace Entire Ramp.
