Access Compliance Report
Public Rights-of-Way
(Curb Ramps)

Intersection ID: 42370 **Main Street:** BENTGRASS_RUN_DR **Cross Street:** WHISTLER'S_CHASE_DR **Location:** E

ADA ID: BE112ECCEF69 **Ramp Type:** PerpDiag **Initial Pass/Fail:** Fail **Overall Compliance:** No **Severity Score:** 22.5

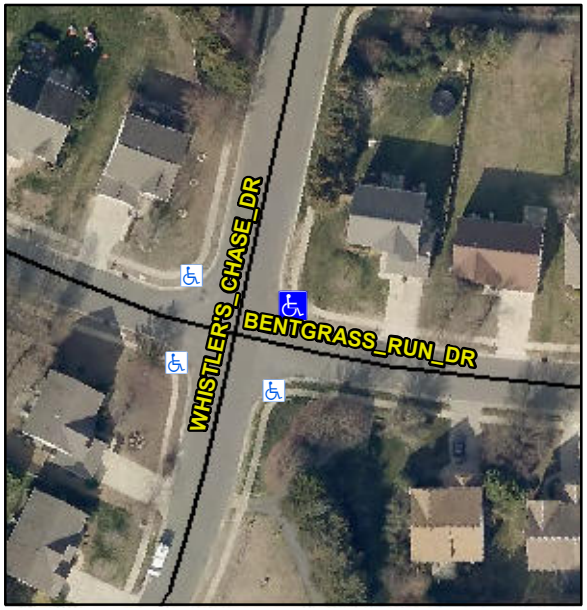
Not Found, R304.5.1, R304.2.2, R304.5.3

Compliance	Description	Data	Compliance	Description	Data
N/A	Ramp Length (in)	49.0	No	Ramp Slope (%)	8.7
No	Ramp Width (in)	41.0	No	Ramp XSlope (%)	2.7
N/A	Flare Type LT	N/A	N/A	Flare Type RT	N/A
N/A	Flare Slope LT (%)	N/A	N/A	Flare Slope RT (%)	N/A
N/A	Flare Traversable LT?	N/A	N/A	Flare Traversable RT?	N/A
N/A	Landing Length (in)	N/A	N/A	DWS Provided?	N/A
N/A	Landing Width (in)	N/A	N/A	DWS Contrast?	N/A
N/A	Landing Slope (%)	N/A	N/A	DWS Length (in)	N/A
N/A	Landing X Slope (%)	N/A	N/A	DWS Full Width?	N/A
N/A	Landing Curb? (Y/N)	N/A	N/A	DWS Offset (in)	N/A
N/A	Shared Landing?	N/A			
N/A	Gutter Ponding?	N/A	N/A	Gutter Slope (%)	N/A
N/A	Gutter Lip Ht (in)	N/A	N/A	Gutter X Slope (%)	N/A
N/A	Painted X Walk1?	No	N/A	Painted X Walk2?	No
	X Walk 1 Direction	To NW		X Walk 2 Direction	To SW
N/A	X Walk 1 Width (in)	N/A	N/A	X Walk 2 Width (in)	N/A
	X Walk 1 Slope (%)	2.0		X Walk 2 Slope (%)	0.0
	X Walk 1 X Slope (%)	0.5		X Walk 2 X Slope (%)	3.3

Remove & Replace Curb Ramp With Two New Directional Ramps or Equivalent.
