Access Compliance Report
Public Rights-of-Way
(Curb Ramps)

Intersection ID: 10020400	Main Street: BALLANTYNE_GLEN_WY	Cross Street: N/A	Location:	SW
ADA ID: BE7704B273B8	Ramp Type: Perp	Initial Pass/Fail: Fail	Overall Compliance: No	Severity Score: 33.75

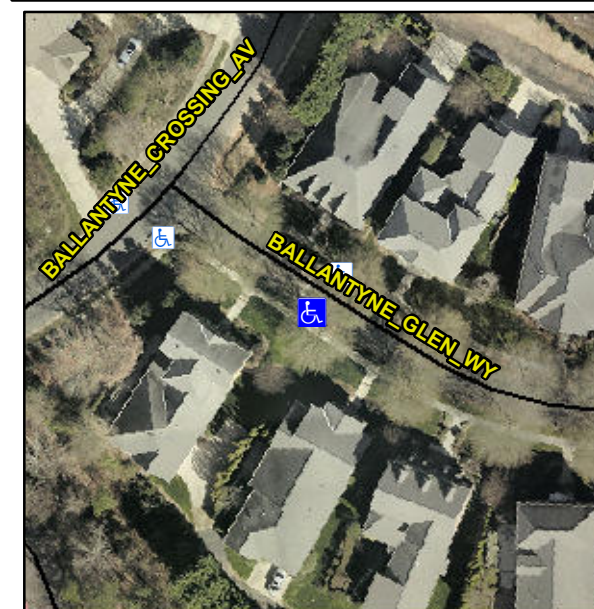
Not Found, R304.5.1, R304.2.2, R304.5.3

Compliance	Description	Data	Compliance	Description	Data
N/A	Ramp Length (in)	62.0	No	Ramp Slope (%)	9.5
No	Ramp Width (in)	47.5	No	Ramp XSlope (%)	5.8
N/A	Flare Type LT	N/A	N/A	Flare Type RT	N/A
N/A	Flare Slope LT (%)	N/A	N/A	Flare Slope RT (%)	N/A
N/A	Flare Traversable LT?	N/A	N/A	Flare Traversable RT?	N/A
N/A	Landing Length (in)	N/A	N/A	DWS Provided?	N/A
N/A	Landing Width (in)	N/A	N/A	DWS Contrast?	N/A
N/A	Landing Slope (%)	N/A	N/A	DWS Length (in)	N/A
N/A	Landing X Slope (%)	N/A	N/A	DWS Full Width?	N/A
N/A	Landing Curb? (Y/N)	N/A	N/A	DWS Offset (in)	N/A
N/A	Shared Landing?	N/A			
N/A	Gutter Ponding?	N/A	N/A	Gutter Slope (%)	N/A
N/A	Gutter Lip Ht (in)	N/A	N/A	Gutter X Slope (%)	N/A
N/A	Painted X Walk1?	No	N/A	Painted X Walk2?	N/A
	X Walk 1 Direction	To NE		X Walk 2 Direction	N/A
N/A	X Walk 1 Width (in)	N/A	N/A	X Walk 2 Width (in)	N/A
	X Walk 1 Slope (%)	1.3		X Walk 2 Slope (%)	N/A
	X Walk 1 X Slope (%)	6.7		X Walk 2 X Slope (%)	N/A

Remove & Replace Entire Ramp.
