# Access Compliance Report
# Public Rights-of-Way
# (Curb Ramps)

| Intersection ID: N/A | Main Street: ELGIN_MOOR_RD | Cross Street: DOUGLAS_PALACE_CT | Location: | NW |
| ADA ID: BEB05EBE0FC6 | Ramp Type: Perp | Initial Pass/Fail: Fail | Overall Compliance: No | Severity Score: 1.25 |

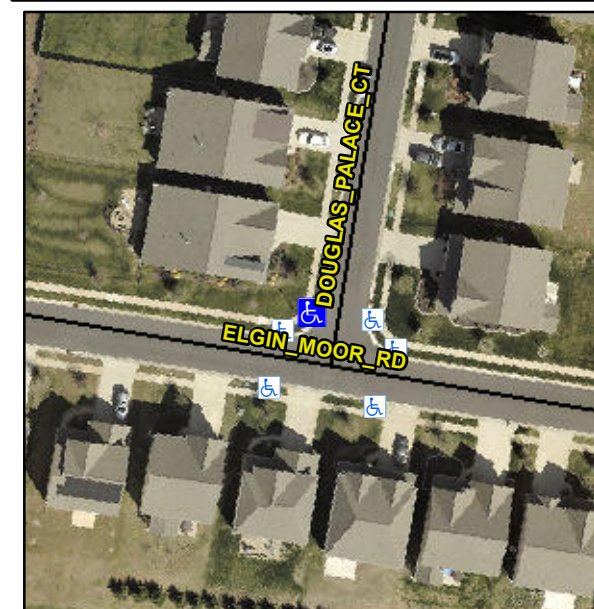
**Not Found, R304.5.3**

| Compliance | Description | Data | Compliance | Description | Data |
|---|---|---|---|---|---|
| Yes | Ramp Width (in) | 48.0 | No | Ramp XSlope (%) | 2.5 |

**Remove & Replace Entire Ramp.**
