Access Compliance Report
Public Rights-of-Way
(Curb Ramps)

Intersection ID: 25678	**Main Street:** CARMEL_EXECUTIVE_PARK	**Cross Street:** CARMEL_RD	**Location:** **W**
ADA ID: BFC0B44262E2	**Ramp Type:** IslandPerp	**Initial Pass/Fail: Fail** **Overall Compliance: No**	**Severity Score:** **12.5**

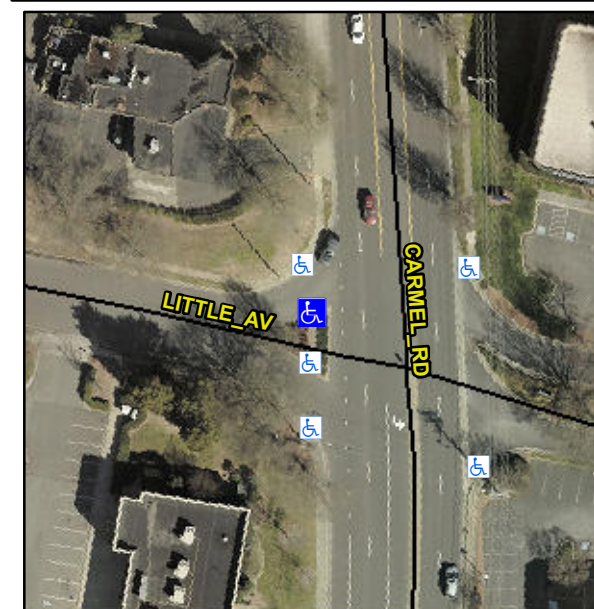
Not Found, R304.2.2

Compliance	Description	Data	Compliance	Description	Data
N/A	Ramp Length (in)	70.0	No	Ramp Slope (%)	8.6
Yes	Ramp Width (in)	54.0	Yes	Ramp XSlope (%)	2.0
N/A	Flare Type LT	N/A	N/A	Flare Type RT	N/A
N/A	Flare Slope LT (%)	N/A	N/A	Flare Slope RT (%)	N/A
N/A	Flare Traversable LT?	N/A	N/A	Flare Traversable RT?	N/A
N/A	Landing Length (in)	N/A	N/A	DWS Provided?	N/A
N/A	Landing Width (in)	N/A	N/A	DWS Contrast?	N/A
N/A	Landing Slope (%)	N/A	N/A	DWS Length (in)	N/A
N/A	Landing X Slope (%)	N/A	N/A	DWS Full Width?	N/A
N/A	Landing Curb? (Y/N)	N/A	N/A	DWS Offset (in)	N/A
N/A	Shared Landing?	N/A			
N/A	Gutter Ponding?	N/A	N/A	Gutter Slope (%)	N/A
N/A	Gutter Lip Ht (in)	N/A	N/A	Gutter X Slope (%)	N/A
N/A	Painted X Walk1?	No	N/A	Painted X Walk2?	N/A
	X Walk 1 Direction	To N		X Walk 2 Direction	N/A
N/A	X Walk 1 Width (in)	N/A	N/A	X Walk 2 Width (in)	N/A
	X Walk 1 Slope (%)	1.0		X Walk 2 Slope (%)	N/A
	X Walk 1 X Slope (%)	0.1		X Walk 2 X Slope (%)	N/A

Remove & Replace Entire Ramp.
