Access Compliance Report
Public Rights-of-Way
(Curb Ramps)

Intersection ID: 10011781	Main Street: PIERSON_DR	Cross Street: N/A	Location: N
ADA ID: C13756BE2FA8	Ramp Type: Perp	Initial Pass/Fail: Fail	Overall Compliance: No Severity Score: 12.5

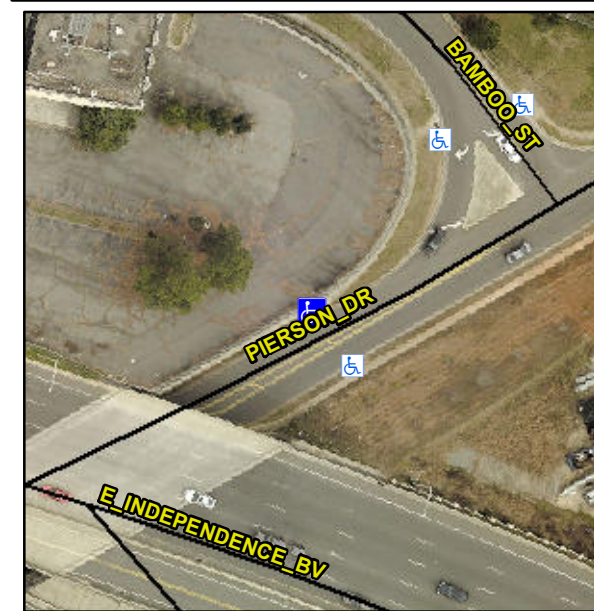
Not Found, R304.5.3

Compliance	Description	Data	Compliance	Description	Data
N/A	Ramp Length (in)	103.0	Yes	Ramp Slope (%)	6.1
Yes	Ramp Width (in)	64.0	No	Ramp XSlope (%)	5.5
N/A	Flare Type LT	N/A	N/A	Flare Type RT	N/A
N/A	Flare Slope LT (%)	N/A	N/A	Flare Slope RT (%)	N/A
N/A	Flare Traversable LT?	N/A	N/A	Flare Traversable RT?	N/A
N/A	Landing Length (in)	N/A	N/A	DWS Provided?	N/A
N/A	Landing Width (in)	N/A	N/A	DWS Contrast?	N/A
N/A	Landing Slope (%)	N/A	N/A	DWS Length (in)	N/A
N/A	Landing X Slope (%)	N/A	N/A	DWS Full Width?	N/A
N/A	Landing Curb? (Y/N)	N/A	N/A	DWS Offset (in)	N/A
N/A	Shared Landing?	N/A			
N/A	Gutter Ponding?	N/A	N/A	Gutter Slope (%)	N/A
N/A	Gutter Lip Ht (in)	N/A	N/A	Gutter X Slope (%)	N/A
N/A	Painted X Walk1?	No	N/A	Painted X Walk2?	N/A
	X Walk 1 Direction	To S		X Walk 2 Direction	N/A
N/A	X Walk 1 Width (in)	N/A	N/A	X Walk 2 Width (in)	N/A
	X Walk 1 Slope (%)	0.5		X Walk 2 Slope (%)	N/A
	X Walk 1 X Slope (%)	5.8		X Walk 2 X Slope (%)	N/A

Remove & Replace Entire Ramp.
