Access Compliance Report
Public Rights-of-Way
(Curb Ramps)

Intersection ID: 12524	Main Street: W_1ST_ST	Cross Street: S_CHURCH_ST	Location:	N
ADA ID: C1472C75B80F	Ramp Type: PerpDiag	Initial Pass/Fail: Fail	Overall Compliance: No	Severity Score: 26.25

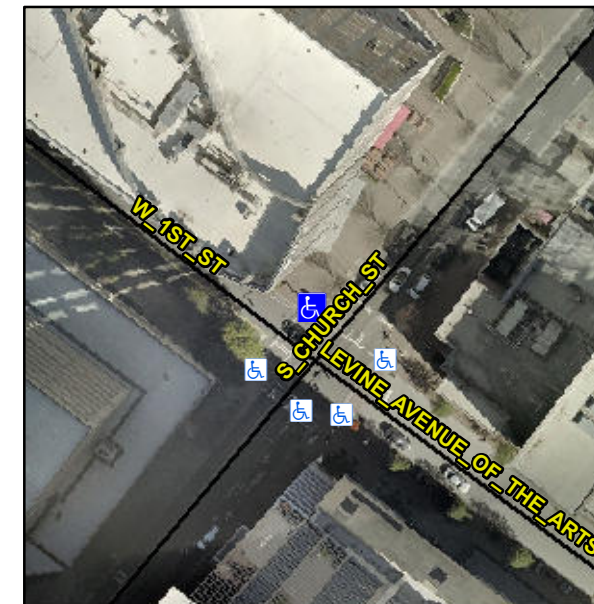
Not Found, R304.2.2

Compliance	Description	Data	Compliance	Description	Data
N/A	Ramp Length (in)	24.0	No	Ramp Slope (%)	12.1
Yes	Ramp Width (in)	82.0	Yes	Ramp XSlope (%)	2.5
N/A	Flare Type LT	N/A	N/A	Flare Type RT	N/A
N/A	Flare Slope LT (%)	N/A	N/A	Flare Slope RT (%)	N/A
N/A	Flare Traversable LT?	N/A	N/A	Flare Traversable RT?	N/A
N/A	Landing Length (in)	N/A	N/A	DWS Provided?	N/A
N/A	Landing Width (in)	N/A	N/A	DWS Contrast?	N/A
N/A	Landing Slope (%)	N/A	N/A	DWS Length (in)	N/A
N/A	Landing X Slope (%)	N/A	N/A	DWS Full Width?	N/A
N/A	Landing Curb? (Y/N)	N/A	N/A	DWS Offset (in)	N/A
N/A	Shared Landing?	N/A			
N/A	Gutter Ponding?	N/A	N/A	Gutter Slope (%)	N/A
N/A	Gutter Lip Ht (in)	N/A	N/A	Gutter X Slope (%)	N/A
N/A	Painted X Walk1?	Yes	N/A	Painted X Walk2?	Yes
	X Walk 1 Direction	To SW		X Walk 2 Direction	To SE
N/A	X Walk 1 Width (in)	110.0	N/A	X Walk 2 Width (in)	83.0
	X Walk 1 Slope (%)	1.1		X Walk 2 Slope (%)	1.6
	X Walk 1 X Slope (%)	4.6		X Walk 2 X Slope (%)	2.1

Remove & Replace Curb Ramp With Two New Directional Ramps or Equivalent.
