Access Compliance Report
Public Rights-of-Way
(Curb Ramps)

Intersection ID: 46686	Main Street: GOLDFIELDS_DR	Cross Street: AYERS_ORCHARD_WY	Location: SE
ADA ID: C241A858856D	Ramp Type: PerpDiag	Initial Pass/Fail: Fail	Overall Compliance: No	Severity Score: 8.75

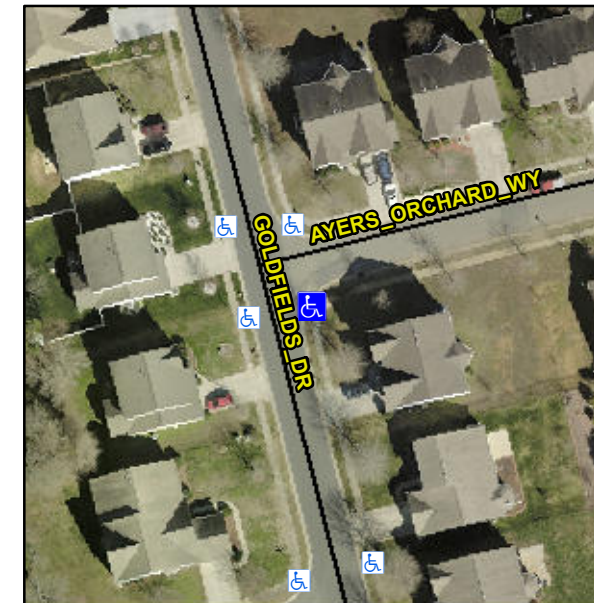
Not Found, R304.5.1

Compliance	Description	Data	Compliance	Description	Data
N/A	Ramp Length (in)	49.0	Yes	Ramp Slope (%)	5.3
No	Ramp Width (in)	45.0	Yes	Ramp XSlope (%)	0.3
N/A	Flare Type LT	N/A	N/A	Flare Type RT	N/A
N/A	Flare Slope LT (%)	N/A	N/A	Flare Slope RT (%)	N/A
N/A	Flare Traversable LT?	N/A	N/A	Flare Traversable RT?	N/A
N/A	Landing Length (in)	N/A	N/A	DWS Provided?	N/A
N/A	Landing Width (in)	N/A	N/A	DWS Contrast?	N/A
N/A	Landing Slope (%)	N/A	N/A	DWS Length (in)	N/A
N/A	Landing X Slope (%)	N/A	N/A	DWS Full Width?	N/A
N/A	Landing Curb? (Y/N)	N/A	N/A	DWS Offset (in)	N/A
N/A	Shared Landing?	N/A			
N/A	Gutter Ponding?	N/A	N/A	Gutter Slope (%)	N/A
N/A	Gutter Lip Ht (in)	N/A	N/A	Gutter X Slope (%)	N/A
N/A	Painted X Walk1?	No	N/A	Painted X Walk2?	No
	X Walk 1 Direction	To N		X Walk 2 Direction	To W
N/A	X Walk 1 Width (in)	N/A	N/A	X Walk 2 Width (in)	N/A
	X Walk 1 Slope (%)	2.1		X Walk 2 Slope (%)	2.5
	X Walk 1 X Slope (%)	0.1		X Walk 2 X Slope (%)	1.8

Remove & Replace Curb Ramp With Two New Directional Ramps or Equivalent.
