# Access Compliance Report
# Public Rights-of-Way
# (Curb Ramps)

| Intersection ID: 50708 | Main Street: CELEBRATION_RD | Cross Street: BROTHERLY_LN | Location: | NE |
| ADA ID: C3572D54A25E | Ramp Type: PerpDiag | Initial Pass/Fail: Fail | Overall Compliance: No | Severity Score: 12.5 |

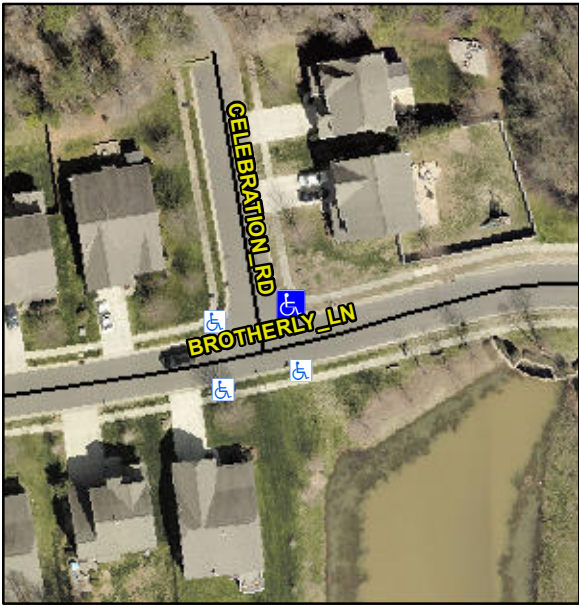
| Compliance | Description | Data | Compliance | Description | Data |
|---|---|---|---|---|---|
| N/A | Ramp Length (in) | 48.0 | No | Ramp Slope (%) | 9.3 |

**Remove & Replace Curb Ramp With Two New Directional Ramps or Equivalent.**
