Access Compliance Report
Public Rights-of-Way
(Curb Ramps)

Intersection ID: 53351	Main Street: MARVIN_RD	Cross Street: SAPPHIRE_HILL_LN	Location:	SW
ADA ID: C3916051AFA0	Ramp Type: Combination1	Initial Pass/Fail: Fail	Overall Compliance: No	Severity Score: 50

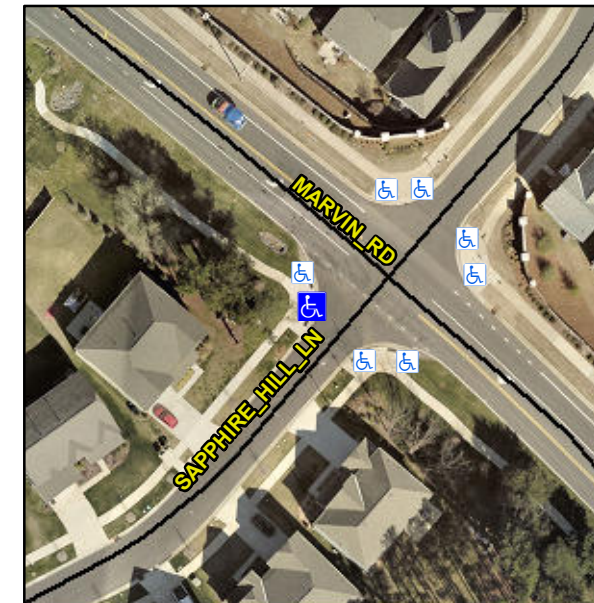
Not Found, R304.5.3, R304.3.2

Compliance	Description	Data	Compliance	Description	Data
N/A	Ramp Length LT (in)	54.0	N/A	Ramp Length RT (in)	50.0
Yes	Ramp Width LT (in)	59.0	Yes	Ramp Width RT (in)	60.0
No	Ramp Slope LT (%)	11.6	No	Ramp Slope RT (%)	14.5
Yes	Ramp XSlope LT (%)	1.8	Yes	Ramp XSlope RT (%)	0.6
N/A	Ramp Length (in)	96.0	Yes	Ramp Slope (%)	5.6
Yes	Ramp Width (in)	48.0	No	Ramp XSlope (%)	10.0
N/A	Flare Type LT	N/A	N/A	Flare Type RT	N/A
N/A	Flare Slope LT (%)	N/A	N/A	Flare Slope RT (%)	N/A
N/A	Flare Traversable LT?	N/A	N/A	Flare Traversable RT?	N/A
N/A	Landing Length (in)	N/A	N/A	DWS Provided?	N/A
N/A	Landing Width (in)	N/A	N/A	DWS Contrast?	N/A
N/A	Landing Slope (%)	N/A	N/A	DWS Length (in)	N/A
N/A	Landing X Slope (%)	N/A	N/A	DWS Full Width?	N/A
N/A	Landing Curb? (Y/N)	N/A	N/A	DWS Offset (in)	N/A
N/A	Shared Landing?	N/A			
N/A	Gutter Ponding?	N/A	N/A	Gutter Slope (%)	N/A
N/A	Gutter Lip Ht (in)	1.0	N/A	Gutter X Slope (%)	N/A
N/A	Painted X Walk1?	No	N/A	Painted X Walk2?	N/A

Remove & Replace Entire Ramp.
