Access Compliance Report
Public Rights-of-Way
(Curb Ramps)

Intersection ID: 8276	**Main Street: BROOKSHIRE_BV**	**Cross Street: N_LINWOOD_AV**	**Location: NE**
ADA ID: C554A5EA2A9D	**Ramp Type: Para**	**Initial Pass/Fail: Fail** **Overall Compliance: No**	**Severity Score: 13.75**

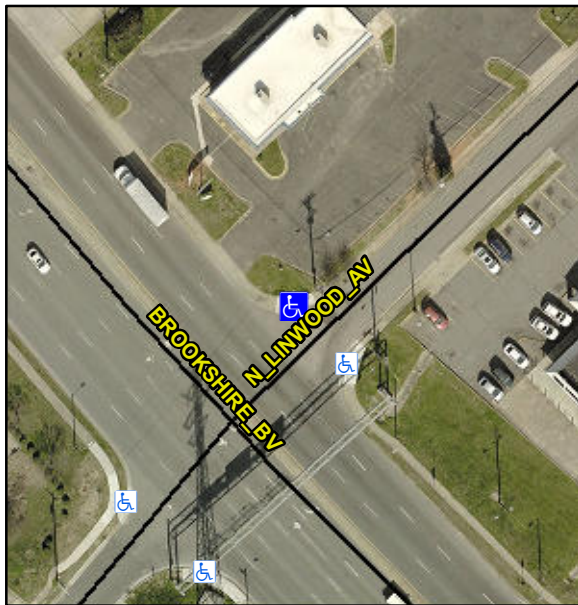
LT RP < 5%

R304.5.3, R304.3.2

Compliance	Description	Data	Compliance	Description	Data
N/A	Ramp Length LT (in)	59.5	N/A	Ramp Length RT (in)	72.0
Yes	Ramp Width LT (in)	66.0	Yes	Ramp Width RT (in)	68.0
Yes	Ramp Slope LT (%)	3.2	No	Ramp Slope RT (%)	8.7
No	Ramp XSlope LT (%)	2.4	No	Ramp XSlope RT (%)	2.9
N/A	Landing Length (in)	N/A	N/A	DWS Provided?	N/A
N/A	Landing Width (in)	N/A	N/A	DWS Contrast?	N/A
N/A	Landing Slope (%)	N/A	N/A	DWS Length (in)	N/A
N/A	Landing X Slope (%)	N/A	N/A	DWS Full Width?	N/A
N/A	Landing Curb? (Y/N)	N/A	N/A	DWS Offset (in)	N/A
N/A	Shared Landing?	N/A			
N/A	Gutter Ponding?	N/A	N/A	Gutter Slope (%)	N/A
N/A	Gutter Lip Ht (in)	N/A	N/A	Gutter X Slope (%)	N/A
N/A	Painted X Walk1?	No	N/A	Painted X Walk2?	N/A
	X Walk 1 Direction	To SE		X Walk 2 Direction	N/A
N/A	X Walk 1 Width (in)	N/A	N/A	X Walk 2 Width (in)	N/A
	X Walk 1 Slope (%)	2.0		X Walk 2 Slope (%)	N/A
	X Walk 1 X Slope (%)	0.7		X Walk 2 X Slope (%)	N/A
N/A	Ramp inside XWalk1?	N/A	N/A	Ramp inside XWalk2?	N/A

Remove & Replace Entire Ramp.
