Access Compliance Report
Public Rights-of-Way
(Curb Ramps)

Intersection ID: 5073	Main Street: FROSTMOOR_PL	Cross Street: HEDGECREST_PL	Location:	SW
ADA ID: C5A9FA137E6D	Ramp Type: Perp	Initial Pass/Fail: Fail	Overall Compliance: No	Severity Score: 33.75

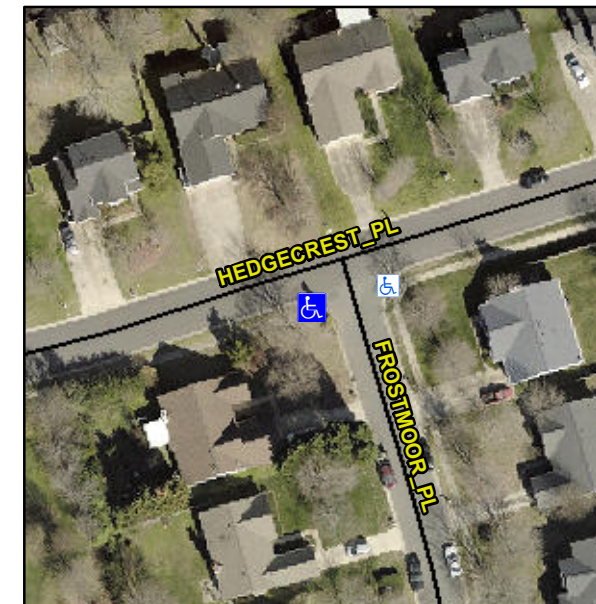
Not Found, R304.5.1, R304.2.2

Compliance	Description	Data	Compliance	Description	Data
N/A	Ramp Length (in)	51.0	No	Ramp Slope (%)	14.3
No	Ramp Width (in)	47.0	Yes	Ramp XSlope (%)	1.3
N/A	Flare Type LT	N/A	N/A	Flare Type RT	N/A
N/A	Flare Slope LT (%)	N/A	N/A	Flare Slope RT (%)	N/A
N/A	Flare Traversable LT?	N/A	N/A	Flare Traversable RT?	N/A
N/A	Landing Length (in)	N/A	N/A	DWS Provided?	N/A
N/A	Landing Width (in)	N/A	N/A	DWS Contrast?	N/A
N/A	Landing Slope (%)	N/A	N/A	DWS Length (in)	N/A
N/A	Landing X Slope (%)	N/A	N/A	DWS Full Width?	N/A
N/A	Landing Curb? (Y/N)	N/A	N/A	DWS Offset (in)	N/A
N/A	Shared Landing?	N/A			
N/A	Gutter Ponding?	N/A	N/A	Gutter Slope (%)	N/A
N/A	Gutter Lip Ht (in)	N/A	N/A	Gutter X Slope (%)	N/A
N/A	Painted X Walk1?	No	N/A	Painted X Walk2?	N/A
	X Walk 1 Direction	To E		X Walk 2 Direction	N/A
N/A	X Walk 1 Width (in)	N/A	N/A	X Walk 2 Width (in)	N/A
	X Walk 1 Slope (%)	2.3		X Walk 2 Slope (%)	N/A
	X Walk 1 X Slope (%)	1.0		X Walk 2 X Slope (%)	N/A

Remove & Replace Entire Ramp.
