Access Compliance Report
Public Rights-of-Way
(Curb Ramps)

Intersection ID: 9951	**Main Street:** S_TURNER_AV	**Cross Street:** W_TRADE_ST	**Location:** W
ADA ID: C5D51E44179D	**Ramp Type:** Perp	**Initial Pass/Fail:** Fail	**Overall Compliance:** No **Severity Score:** 22.5

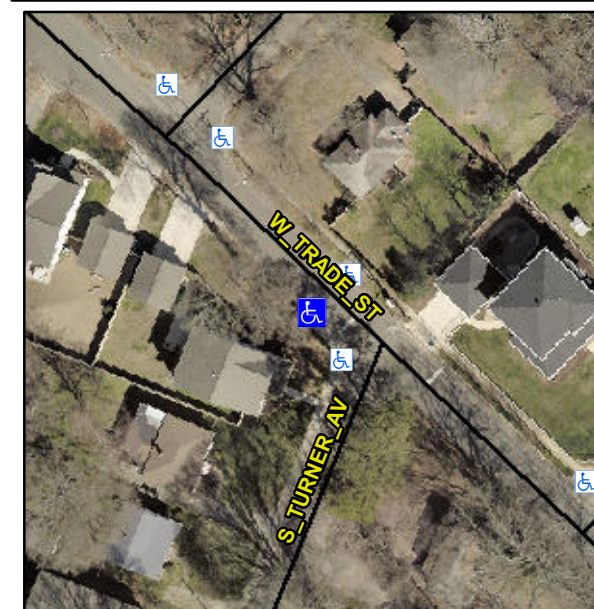
Not Found, R304.5.1, R304.2.2, R304.5.3

Compliance	Description	Data	Compliance	Description	Data
N/A	Ramp Length (in)	60.0	No	Ramp Slope (%)	10.0
No	Ramp Width (in)	47.0	No	Ramp XSlope (%)	3.6
N/A	Flare Type LT	N/A	N/A	Flare Type RT	N/A
N/A	Flare Slope LT (%)	N/A	N/A	Flare Slope RT (%)	N/A
N/A	Flare Traversable LT?	N/A	N/A	Flare Traversable RT?	N/A
N/A	Landing Length (in)	N/A	N/A	DWS Provided?	N/A
N/A	Landing Width (in)	N/A	N/A	DWS Contrast?	N/A
N/A	Landing Slope (%)	N/A	N/A	DWS Length (in)	N/A
N/A	Landing X Slope (%)	N/A	N/A	DWS Full Width?	N/A
N/A	Landing Curb? (Y/N)	N/A	N/A	DWS Offset (in)	N/A
N/A	Shared Landing?	N/A			
N/A	Gutter Ponding?	N/A	N/A	Gutter Slope (%)	N/A
N/A	Gutter Lip Ht (in)	N/A	N/A	Gutter X Slope (%)	N/A
N/A	Painted X Walk1?	No	N/A	Painted X Walk2?	N/A
	X Walk 1 Direction	To NE		X Walk 2 Direction	N/A
N/A	X Walk 1 Width (in)	N/A	N/A	X Walk 2 Width (in)	N/A
	X Walk 1 Slope (%)	1.1		X Walk 2 Slope (%)	N/A
	X Walk 1 X Slope (%)	3.9		X Walk 2 X Slope (%)	N/A

Remove & Replace Entire Ramp.
