Access Compliance Report
Public Rights-of-Way
(Curb Ramps)

Intersection ID: 18814	**Main Street: COLONY_RD**	**Cross Street: FERNCLIFF_RD**	**Location: E**
ADA ID: C6C2DC48B0F8	**Ramp Type: PerpDiag**	**Initial Pass/Fail: Fail**	**Overall Compliance: No** / **Severity Score: 33.75**

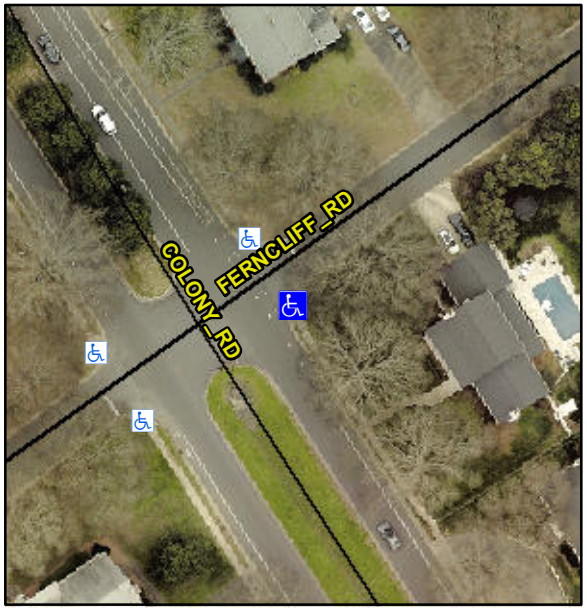
R304.5.1, R304.2.2

Compliance	Description	Data	Compliance	Description	Data
N/A	Ramp Length (in)	47.5	No	Ramp Slope (%)	13.8
No	Ramp Width (in)	43.0	Yes	Ramp XSlope (%)	0.5
N/A	Flare Type LT	N/A	N/A	Flare Type RT	N/A
N/A	Flare Slope LT (%)	N/A	N/A	Flare Slope RT (%)	N/A
N/A	Flare Traversable LT?	N/A	N/A	Flare Traversable RT?	N/A
N/A	Landing Length (in)	N/A	N/A	DWS Provided?	N/A
N/A	Landing Width (in)	N/A	N/A	DWS Contrast?	N/A
N/A	Landing Slope (%)	N/A	N/A	DWS Length (in)	N/A
N/A	Landing X Slope (%)	N/A	N/A	DWS Full Width?	N/A
N/A	Landing Curb? (Y/N)	N/A	N/A	DWS Offset (in)	N/A
N/A	Shared Landing?	N/A			
N/A	Gutter Ponding?	N/A	N/A	Gutter Slope (%)	N/A
N/A	Gutter Lip Ht (in)	N/A	N/A	Gutter X Slope (%)	N/A
N/A	Painted X Walk1?	No	N/A	Painted X Walk2?	No
	X Walk 1 Direction	To W		X Walk 2 Direction	To N
N/A	X Walk 1 Width (in)	N/A	N/A	X Walk 2 Width (in)	N/A
	X Walk 1 Slope (%)	2.4		X Walk 2 Slope (%)	10.4
	X Walk 1 X Slope (%)	2.5		X Walk 2 X Slope (%)	1.1

Remove & Replace Curb Ramp With Two New Directional Ramps or Equivalent.
