Access Compliance Report
Public Rights-of-Way
(Curb Ramps)

Intersection ID: 44465	Main Street: AINSWORTH_ST	Cross Street: VALCOURT_RD	Location:	NE
ADA ID: C6DF15B1F28E	Ramp Type: PerpDiag	Initial Pass/Fail: Fail	Overall Compliance: No	Severity Score: 35

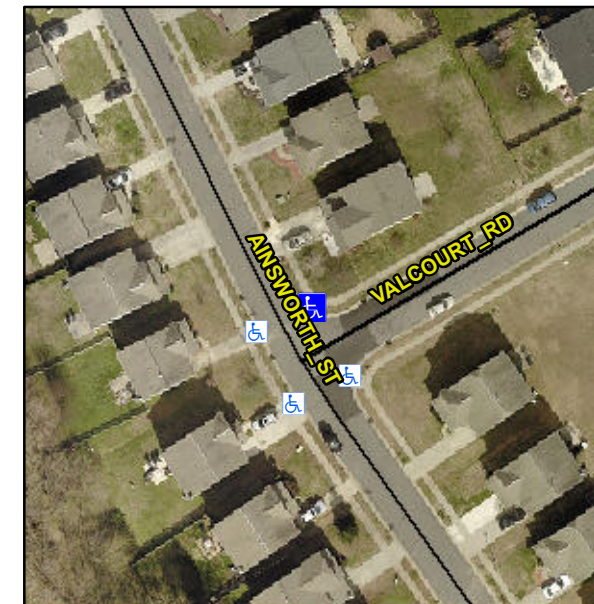
Compliance	Description	Data	Compliance	Description	Data
N/A	Ramp Length (in)	48.0	Yes	Ramp Slope (%)	7.7
No	Ramp Width (in)	31.0	Yes	Ramp XSlope (%)	1.5
N/A	Flare Type LT	N/A	N/A	Flare Type RT	N/A
N/A	Flare Slope LT (%)	N/A	N/A	Flare Slope RT (%)	N/A
N/A	Flare Traversable LT?	N/A	N/A	Flare Traversable RT?	N/A
N/A	Landing Length (in)	N/A	N/A	DWS Provided?	N/A
N/A	Landing Width (in)	N/A	N/A	DWS Contrast?	N/A
N/A	Landing Slope (%)	N/A	N/A	DWS Length (in)	N/A
N/A	Landing X Slope (%)	N/A	N/A	DWS Full Width?	N/A
N/A	Landing Curb? (Y/N)	N/A	N/A	DWS Offset (in)	N/A
N/A	Shared Landing?	N/A			
N/A	Gutter Ponding?	N/A	N/A	Gutter Slope (%)	N/A
N/A	Gutter Lip Ht (in)	N/A	N/A	Gutter X Slope (%)	N/A
N/A	Painted X Walk1?	No	N/A	Painted X Walk2?	No
	X Walk 1 Direction	To W		X Walk 2 Direction	To S
N/A	X Walk 1 Width (in)	N/A	N/A	X Walk 2 Width (in)	N/A
	X Walk 1 Slope (%)	1.2		X Walk 2 Slope (%)	3.8
	X Walk 1 X Slope (%)	2.2		X Walk 2 X Slope (%)	1.1

Remove & Replace Curb Ramp With Two New Directional Ramps or Equivalent.
