# Access Compliance Report
# Public Rights-of-Way
# (Curb Ramps)

**Intersection ID:** 45514 **Main Street:** MEADOW_BOTTOM_RD **Cross Street:** COTTON_PRESS_RD **Location:** N

**ADA ID:** C6FE1F297660 **Ramp Type:** PerpDiag **Initial Pass/Fail:** Fail **Overall Compliance:** No **Severity Score:** 21.25

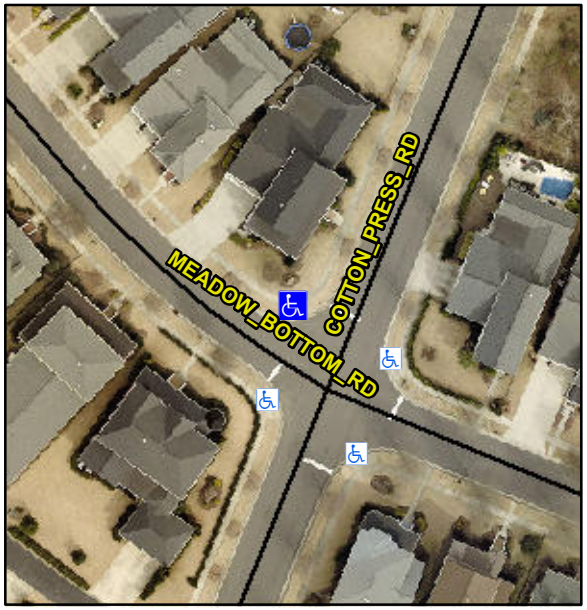
**Not Found, R304.5.1, R304.2.2**

| Compliance | Description | Data | Compliance | Description | Data |
|---|---|---|---|---|---|
| N/A | Ramp Length (in) | 72.0 | No | Ramp Slope (%) | 8.6 |
| No | Ramp Width (in) | 37.0 | Yes | Ramp XSlope (%) | 1.3 |

**Remove & Replace Curb Ramp With Two New Directional Ramps or Equivalent.**
