# Access Compliance Report
## Public Rights-of-Way
## (Curb Ramps)

| Intersection ID: 17455 | Main Street: IDLEWILD_RD | Cross Street: LYNWORTH_PL | Location: | NW |
| ADA ID: C750A97884FC | Ramp Type: PerpDiag | Initial Pass/Fail: Fail | Overall Compliance: No | Severity Score: 12.5 |

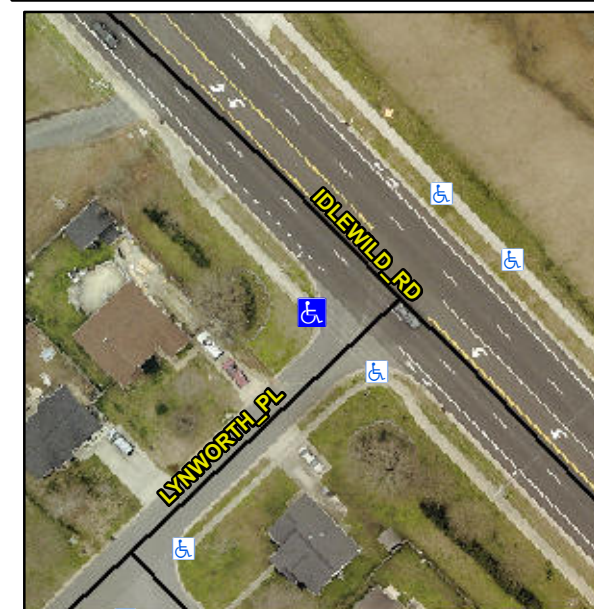
**R304.2.2**

| Compliance | Description | Data | Compliance | Description | Data |
|---|---|---|---|---|---|
| N/A | Ramp Length (in) | 171.0 | No | Ramp Slope (%) | 9.7 |

**Remove & Replace Curb Ramp With Two New Directional Ramps or Equivalent.**
