Access Compliance Report

# Public Rights-of-Way
(Curb Ramps)

Intersection ID: 53777	Main Street: ROCK_ISLAND_RD	Cross Street: MOONLIGHT_BAY_WY	Location: S
ADA ID: C7A40FDF155D	Ramp Type: PerpDiag	Initial Pass/Fail: Fail	Overall Compliance: No	Severity Score: 21.25

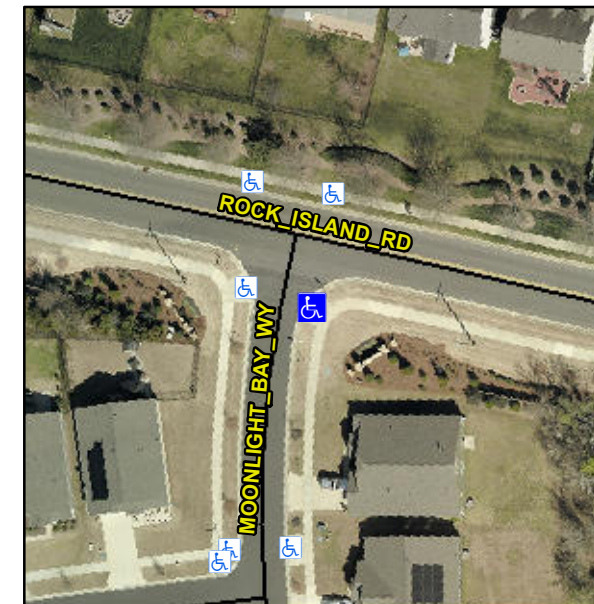
ROCK_ISLAND_RD
MOONLIGHT_BAY_WY

R304.5.1, R304.5.3

Compliance	Description	Data	Compliance	Description	Data
N/A	Ramp Length (in)	99.0	Yes	Ramp Slope (%)	6.8
No	Ramp Width (in)	47.0	No	Ramp XSlope (%)	6.1
N/A	Flare Type LT	N/A	N/A	Flare Type RT	N/A
N/A	Flare Slope LT (%)	N/A	N/A	Flare Slope RT (%)	N/A
N/A	Flare Traversable LT?	N/A	N/A	Flare Traversable RT?	N/A
N/A	Landing Length (in)	N/A	N/A	DWS Provided?	N/A
N/A	Landing Width (in)	N/A	N/A	DWS Contrast?	N/A
N/A	Landing Slope (%)	N/A	N/A	DWS Length (in)	N/A
N/A	Landing X Slope (%)	N/A	N/A	DWS Full Width?	N/A
N/A	Landing Curb? (Y/N)	N/A	N/A	DWS Offset (in)	N/A
N/A	Shared Landing?	N/A			
N/A	Gutter Ponding?	N/A	N/A	Gutter Slope (%)	N/A
N/A	Gutter Lip Ht (in)	1.0	N/A	Gutter X Slope (%)	N/A
N/A	Painted X Walk1?	No	N/A	Painted X Walk2?	No
	X Walk 1 Direction	To NE		X Walk 2 Direction	To NW
N/A	X Walk 1 Width (in)	N/A	N/A	X Walk 2 Width (in)	N/A
	X Walk 1 Slope (%)	3.7		X Walk 2 Slope (%)	0.8
	X Walk 1 X Slope (%)	1.6		X Walk 2 X Slope (%)	3.2

N/A	Ramp inside XWalk1?	N/A	N/A	Ramp inside XWalk2?	N/A
	Road Slope (%)	4.1	N/A	Clear Space?	N/A
	Road X Slope (%)	3.6	N/A	Clear Space to XWalk (in)	N/A
N/A	Any Obstructions?	N/A	N/A	Storm Grate/Utility Hazard?	N/A
	Obstruction Type			Storm Grate/Utility Type	
N/A					N/A
			Yes	Surface Condition? (G/P)	Good

Remove & Replace Curb Ramp With Two New Directional Ramps or Equivalent.
