Access Compliance Report
Public Rights-of-Way
(Curb Ramps)

Intersection ID: 53885	Main Street: PAW_VILLAGE_RD	Cross Street: PATHWAY_CT	Location: NW
ADA ID: C834349FB2A6	Ramp Type: Perp	Initial Pass/Fail: Fail	Overall Compliance: No	Severity Score: 33.75

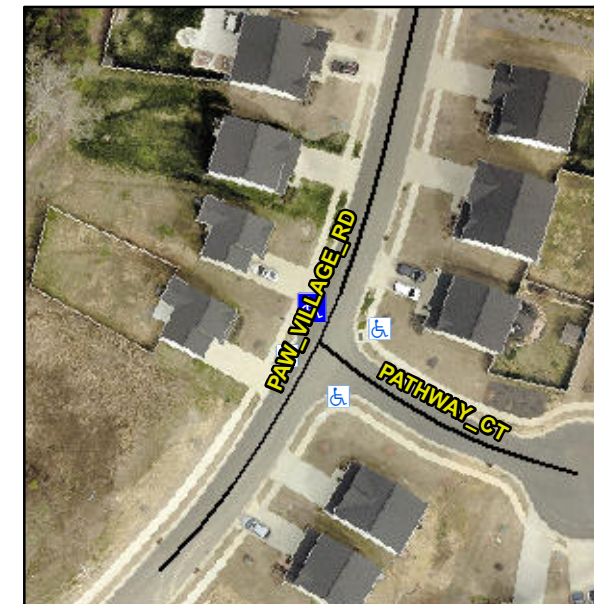
Not Found, R304.5.1, R304.5.3

Compliance	Description	Data	Compliance	Description	Data
N/A	Ramp Length (in)	48.0	Yes	Ramp Slope (%)	6.4
No	Ramp Width (in)	47.5	No	Ramp XSlope (%)	7.0
N/A	Flare Type LT	N/A	N/A	Flare Type RT	N/A
N/A	Flare Slope LT (%)	N/A	N/A	Flare Slope RT (%)	N/A
N/A	Flare Traversable LT?	N/A	N/A	Flare Traversable RT?	N/A
N/A	Landing Length (in)	N/A	N/A	DWS Provided?	N/A
N/A	Landing Width (in)	N/A	N/A	DWS Contrast?	N/A
N/A	Landing Slope (%)	N/A	N/A	DWS Length (in)	N/A
N/A	Landing X Slope (%)	N/A	N/A	DWS Full Width?	N/A
N/A	Landing Curb? (Y/N)	N/A	N/A	DWS Offset (in)	N/A
N/A	Shared Landing?	N/A			
N/A	Gutter Ponding?	N/A	N/A	Gutter Slope (%)	N/A
N/A	Gutter Lip Ht (in)	N/A	N/A	Gutter X Slope (%)	N/A
N/A	Painted X Walk1?	No	N/A	Painted X Walk2?	N/A
	X Walk 1 Direction	To SW		X Walk 2 Direction	N/A
N/A	X Walk 1 Width (in)	N/A	N/A	X Walk 2 Width (in)	N/A
	X Walk 1 Slope (%)	3.8		X Walk 2 Slope (%)	N/A
	X Walk 1 X Slope (%)	10.2		X Walk 2 X Slope (%)	N/A

Remove & Replace Entire Ramp.
