Access Compliance Report

# Public Rights-of-Way
(Curb Ramps)

Intersection ID: 50848	Main Street: REA_RD	Cross Street: BELCHER_LN	Location:	SE
ADA ID: C9FF5B7572B7	Ramp Type: Perp	Initial Pass/Fail: Fail	Overall Compliance: No	Severity Score: 21.25

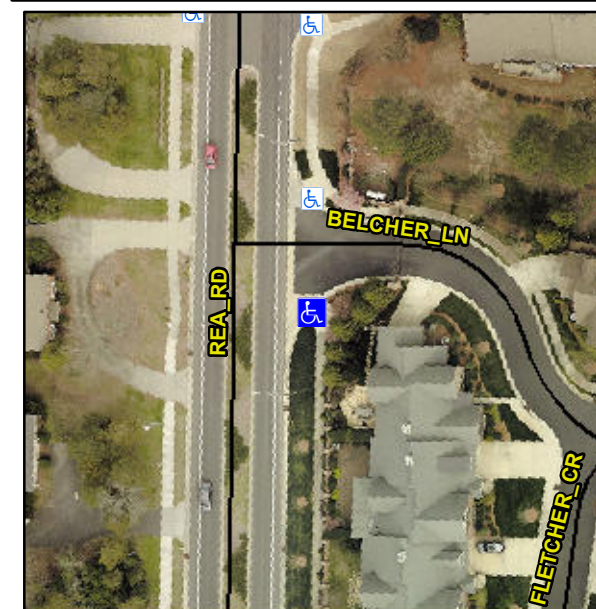
Not Found, R304.5.1, R304.5.3

Compliance	Description	Data	Compliance	Description	Data
N/A	Ramp Length (in)	73.0	Yes	Ramp Slope (%)	5.7
No	Ramp Width (in)	46.5	No	Ramp XSlope (%)	5.4
N/A	Flare Type LT	N/A	N/A	Flare Type RT	N/A
N/A	Flare Slope LT (%)	N/A	N/A	Flare Slope RT (%)	N/A
N/A	Flare Traversable LT?	N/A	N/A	Flare Traversable RT?	N/A
N/A	Landing Length (in)	N/A	N/A	DWS Provided?	N/A
N/A	Landing Width (in)	N/A	N/A	DWS Contrast?	N/A
N/A	Landing Slope (%)	N/A	N/A	DWS Length (in)	N/A
N/A	Landing X Slope (%)	N/A	N/A	DWS Full Width?	N/A
N/A	Landing Curb? (Y/N)	N/A	N/A	DWS Offset (in)	N/A
N/A	Shared Landing?	N/A			
N/A	Gutter Ponding?	N/A	N/A	Gutter Slope (%)	N/A
N/A	Gutter Lip Ht (in)	N/A	N/A	Gutter X Slope (%)	N/A
N/A	Painted X Walk1?	No	N/A	Painted X Walk2?	N/A
	X Walk 1 Direction	To N		X Walk 2 Direction	N/A
N/A	X Walk 1 Width (in)	N/A	N/A	X Walk 2 Width (in)	N/A
	X Walk 1 Slope (%)	2.8		X Walk 2 Slope (%)	N/A
	X Walk 1 X Slope (%)	5.5		X Walk 2 X Slope (%)	N/A

Remove & Replace Entire Ramp.
