Access Compliance Report
Public Rights-of-Way
(Curb Ramps)

Intersection ID: 5092	**Main Street:** BROOKFIELD_POINTE_DR	**Cross Street:** PENNYCROSS_LN	**Location:**	**SE**
ADA ID: CA6547E1C274	**Ramp Type:** Perp	**Initial Pass/Fail:** Fail	**Overall Compliance:** No	**Severity Score:** 13.75

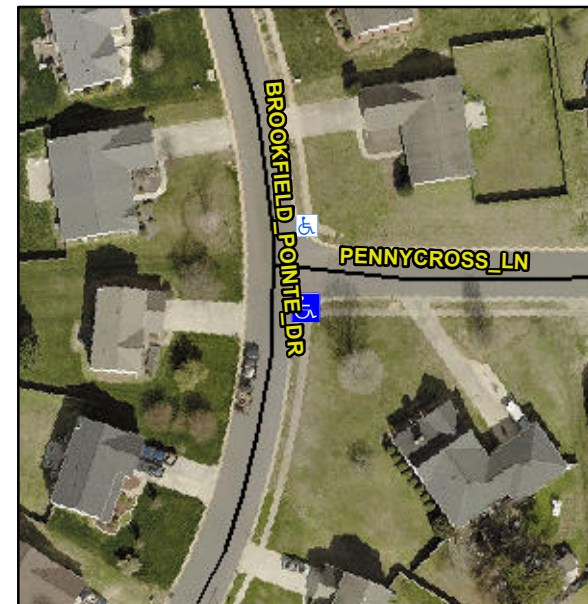
Not Found, R304.2.2, R304.5.3

Compliance	Description	Data	Compliance	Description	Data
N/A	Ramp Length (in)	26.5	No	Ramp Slope (%)	8.4
Yes	Ramp Width (in)	48.0	No	Ramp XSlope (%)	2.8
N/A	Flare Type LT	N/A	N/A	Flare Type RT	N/A
N/A	Flare Slope LT (%)	N/A	N/A	Flare Slope RT (%)	N/A
N/A	Flare Traversable LT?	N/A	N/A	Flare Traversable RT?	N/A
N/A	Landing Length (in)	N/A	N/A	DWS Provided?	N/A
N/A	Landing Width (in)	N/A	N/A	DWS Contrast?	N/A
N/A	Landing Slope (%)	N/A	N/A	DWS Length (in)	N/A
N/A	Landing X Slope (%)	N/A	N/A	DWS Full Width?	N/A
N/A	Landing Curb? (Y/N)	N/A	N/A	DWS Offset (in)	N/A
N/A	Shared Landing?	N/A			
N/A	Gutter Ponding?	N/A	N/A	Gutter Slope (%)	N/A
N/A	Gutter Lip Ht (in)	N/A	N/A	Gutter X Slope (%)	N/A
N/A	Painted X Walk1?	No	N/A	Painted X Walk2?	N/A
	X Walk 1 Direction	To N		X Walk 2 Direction	N/A
N/A	X Walk 1 Width (in)	N/A	N/A	X Walk 2 Width (in)	N/A
	X Walk 1 Slope (%)	1.2		X Walk 2 Slope (%)	N/A
	X Walk 1 X Slope (%)	3.7		X Walk 2 X Slope (%)	N/A

N/A	Ramp inside XWalk1?	N/A	N/A	Ramp inside XWalk2?	N/A
	Road Slope (%)	N/A	N/A	Clear Space?	N/A
	Road X Slope (%)	N/A	N/A	Clear Space to XWalk (in)	N/A
N/A	Any Obstructions?	N/A	N/A	Storm Grate/Utility Hazard?	N/A
	Obstruction Type			Storm Grate/Utility Type	
N/A					N/A
			Yes	Surface Condition? (G/P)	Good

Remove & Replace Entire Ramp.
