Access Compliance Report
Public Rights-of-Way
(Curb Ramps)

Intersection ID: 31813 **Main Street:** WENDOVER_HILL_CT **Cross Street:** CHURCHILL_RD **Location:** SW

ADA ID: CA68DCCD0CCD **Ramp Type:** PerpDiag **Initial Pass/Fail:** Fail **Overall Compliance:** No **Severity Score:** 8.75

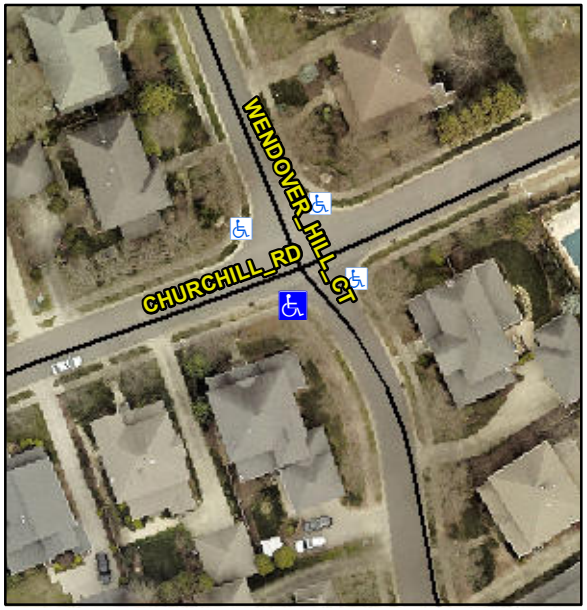
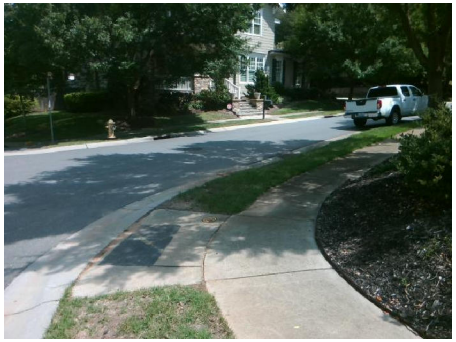
Not Found, R304.5.1

Compliance	Description	Data	Compliance	Description	Data
N/A	Ramp Length (in)	49.0	Yes	Ramp Slope (%)	6.0
No	Ramp Width (in)	47.0	Yes	Ramp XSlope (%)	1.1
N/A	Flare Type LT	N/A	N/A	Flare Type RT	N/A
N/A	Flare Slope LT (%)	N/A	N/A	Flare Slope RT (%)	N/A
N/A	Flare Traversable LT?	N/A	N/A	Flare Traversable RT?	N/A
N/A	Landing Length (in)	N/A	N/A	DWS Provided?	N/A
N/A	Landing Width (in)	N/A	N/A	DWS Contrast?	N/A
N/A	Landing Slope (%)	N/A	N/A	DWS Length (in)	N/A
N/A	Landing X Slope (%)	N/A	N/A	DWS Full Width?	N/A
N/A	Landing Curb? (Y/N)	N/A	N/A	DWS Offset (in)	N/A
N/A	Shared Landing?	N/A			
N/A	Gutter Ponding?	N/A	N/A	Gutter Slope (%)	N/A
N/A	Gutter Lip Ht (in)	N/A	N/A	Gutter X Slope (%)	N/A
N/A	Painted X Walk1?	No	N/A	Painted X Walk2?	No
	X Walk 1 Direction	To E		X Walk 2 Direction	To NW
N/A	X Walk 1 Width (in)	N/A	N/A	X Walk 2 Width (in)	N/A
	X Walk 1 Slope (%)	2.5		X Walk 2 Slope (%)	7.9

X Walk 1 X Slope (%)	1.5		X Walk 2 X Slope (%)	6.1
N/A	Ramp inside XWalk1?	N/A	N/A	Ramp inside XWalk2?	N/A
	Road Slope (%)	0.8	N/A	Clear Space?	N/A
	Road X Slope (%)	5.5	N/A	Clear Space to XWalk (in)	N/A
N/A	Any Obstructions?	N/A	N/A	Storm Grate/Utility Hazard?	N/A
	Obstruction Type			Storm Grate/Utility Type	
		N/A			N/A
			Yes	Surface Condition? (G/P)	Good

Remove & Replace Curb Ramp With Two New Directional Ramps or Equivalent.
