# Access Compliance Report
# Public Rights-of-Way
# (Curb Ramps)

| Intersection ID: N/A | Main Street: YORK_CENTER | Cross Street: N/A | Location: NE |
| ADA ID: CA6ACAA4F72D | Ramp Type: PerpDiag | Initial Pass/Fail: Fail | Overall Compliance: No | Severity Score: 13.75 |

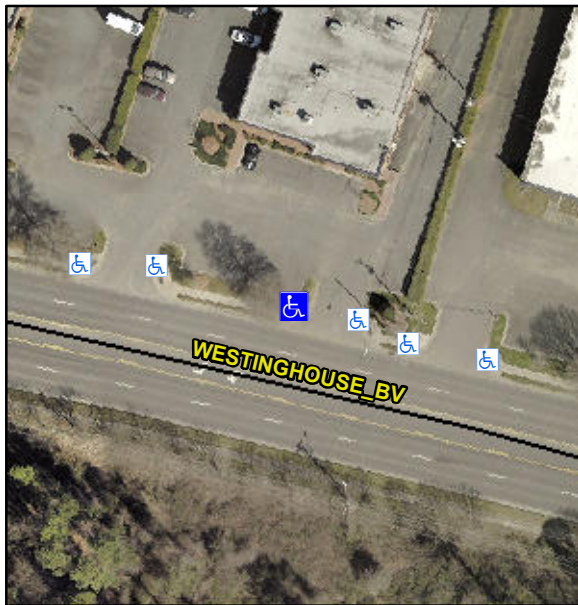
**Not Found, R304.2.2, R304.5.3**

| Compliance | Description | Data | Compliance | Description | Data |
|---|---|---|---|---|---|
| N/A | Ramp Length (in) | 76.0 | No | Ramp Slope (%) | 9.5 |
| Yes | Ramp Width (in) | 67.0 | No | Ramp XSlope (%) | 3.9 |

**Remove & Replace Curb Ramp With Two New Directional Ramps or Equivalent.**
