Access Compliance Report
Public Rights-of-Way
(Curb Ramps)

Intersection ID: 29259	Main Street: PAWLEY_DR	Cross Street: VINE_CLIFF_LN	Location:	W
ADA ID: CAAF41C54A54	Ramp Type: PerpDiag	Initial Pass/Fail: Fail	Overall Compliance: No	Severity Score: 10

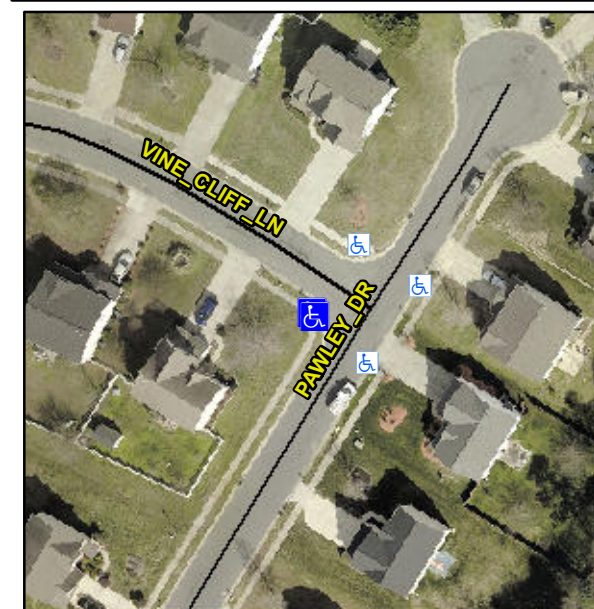
Not Found, R304.5.1, R304.5.3

Compliance	Description	Data	Compliance	Description	Data
N/A	Ramp Length (in)	48.0	Yes	Ramp Slope (%)	5.8
No	Ramp Width (in)	44.0	No	Ramp XSlope (%)	3.0
N/A	Flare Type LT	N/A	N/A	Flare Type RT	N/A
N/A	Flare Slope LT (%)	N/A	N/A	Flare Slope RT (%)	N/A
N/A	Flare Traversable LT?	N/A	N/A	Flare Traversable RT?	N/A
N/A	Landing Length (in)	N/A	N/A	DWS Provided?	N/A
N/A	Landing Width (in)	N/A	N/A	DWS Contrast?	N/A
N/A	Landing Slope (%)	N/A	N/A	DWS Length (in)	N/A
N/A	Landing X Slope (%)	N/A	N/A	DWS Full Width?	N/A
N/A	Landing Curb? (Y/N)	N/A	N/A	DWS Offset (in)	N/A
N/A	Shared Landing?	N/A			
N/A	Gutter Ponding?	N/A	N/A	Gutter Slope (%)	N/A
N/A	Gutter Lip Ht (in)	N/A	N/A	Gutter X Slope (%)	N/A
N/A	Painted X Walk1?	No	N/A	Painted X Walk2?	No
	X Walk 1 Direction	To SE		X Walk 2 Direction	To NE
N/A	X Walk 1 Width (in)	N/A	N/A	X Walk 2 Width (in)	N/A
	X Walk 1 Slope (%)	1.7		X Walk 2 Slope (%)	3.9
	X Walk 1 X Slope (%)	3.3		X Walk 2 X Slope (%)	0.9

N/A	Ramp inside XWalk1?	N/A	N/A	Ramp inside XWalk2?	N/A
	Road Slope (%)	0.7	N/A	Clear Space?	N/A
	Road X Slope (%)	3.5	N/A	Clear Space to XWalk (in)	N/A
N/A	Any Obstructions?	N/A	N/A	Storm Grate/Utility Hazard?	N/A
	Obstruction Type			Storm Grate/Utility Type	
N/A					N/A
			Yes	Surface Condition? (G/P)	Good

Remove & Replace Curb Ramp With Two New Directional Ramps or Equivalent.
