Access Compliance Report
Public Rights-of-Way
(Curb Ramps)

Intersection ID: 25859 **Main Street:** CARY_RIDGE_DR **Cross Street:** CORRIGAN_CT **Location:** NE

ADA ID: CB65B72294FC **Ramp Type:** BlendTrans1 **Initial Pass/Fail:** Fail **Overall Compliance:** No **Severity Score:** 10

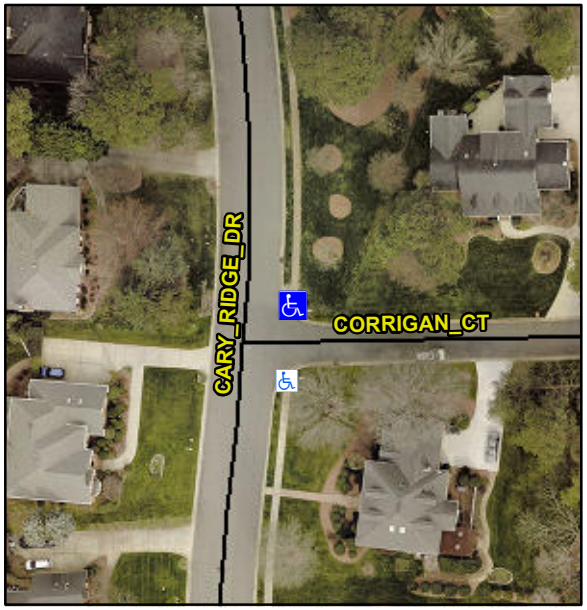
Not Found, R304.5.1, R304.5.3

Compliance	Description	Data	Compliance	Description	Data
N/A	Ramp Length (in)	46.5	Yes	BlendTrans Slope (%)	3.2
No	Ramp Width (in)	42.5	No	BlendTrans XSlope (%)	3.5
N/A	Flare Type LT	N/A	N/A	Flare Type RT	N/A
N/A	Flare Slope LT (%)	N/A	N/A	Flare Slope RT (%)	N/A
N/A	Flare Traversable LT?	N/A	N/A	Flare Traversable RT?	N/A
N/A	Landing Length (in)	N/A	N/A	DWS Provided?	N/A
N/A	Landing Width (in)	N/A	N/A	DWS Contrast?	N/A
N/A	Landing Slope (%)	N/A	N/A	DWS Length (in)	N/A
N/A	Landing X Slope (%)	N/A	N/A	DWS Full Width?	N/A
N/A	Landing Curb? (Y/N)	N/A	N/A	DWS Offset (in)	N/A
N/A	Shared Landing?	N/A			
N/A	Gutter Ponding?	N/A	N/A	Gutter Slope (%)	N/A
N/A	Gutter Lip Ht (in)	N/A	N/A	Gutter X Slope (%)	N/A
N/A	Painted X Walk1?	No	N/A	Painted X Walk2?	No
	X Walk 1 Direction	To W		X Walk 2 Direction	To S
	X Walk 1 Width (in)	N/A		X Walk 2 Width (in)	N/A
	X Walk 1 Slope (%)	3.9		X Walk 2 Slope (%)	2.6
	X Walk 1 X Slope (%)	1.7		X Walk 2 X Slope (%)	2.2

N/A	Ramp inside XWalk1?	N/A	N/A	Ramp inside XWalk2?	N/A
	Road Slope (%)	2.1		Clear Space?	N/A
	Road X Slope (%)	3.9	N/A	Clear Space to XWalk (in)	N/A
N/A	Any Obstructions?	N/A	N/A	Storm Grate/Utility Hazard?	N/A
	Obstruction Type			Storm Grate/Utility Type	
		N/A			N/A
			Yes	Surface Condition? (G/P)	Good
			No	Curb Slope (%)	7.2

Remove & Replace Curb Ramp With Two New Directional Ramps or Equivalent.
