Access Compliance Report
Public Rights-of-Way
(Curb Ramps)

Intersection ID: 24479	Main Street: MEGINGTON_DR	Cross Street: SPRINGS_FARM_LN	Location:	NW
ADA ID: CBD40F4695B1	Ramp Type: PerpDiag	Initial Pass/Fail: Fail	Overall Compliance: No	Severity Score: 8.75

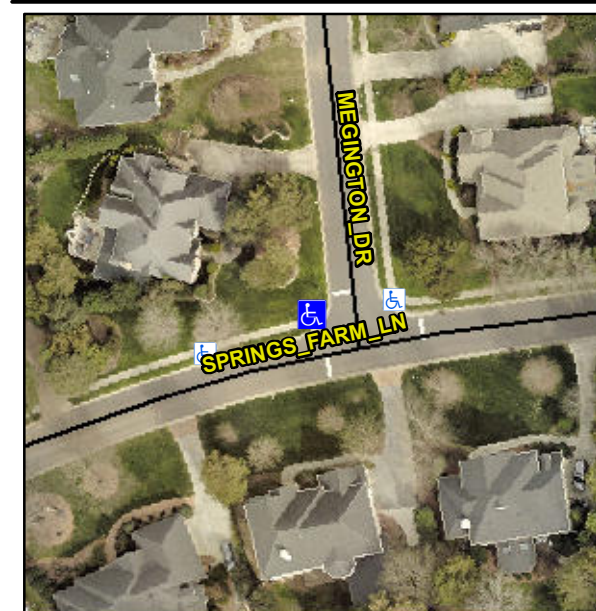
Compliance	Description	Data	Compliance	Description	Data
N/A	Ramp Length (in)	96.0	Yes	Ramp Slope (%)	5.7
No	Ramp Width (in)	47.0	Yes	Ramp XSlope (%)	1.7
N/A	Flare Type LT	N/A	N/A	Flare Type RT	N/A
N/A	Flare Slope LT (%)	N/A	N/A	Flare Slope RT (%)	N/A
N/A	Flare Traversable LT?	N/A	N/A	Flare Traversable RT?	N/A
N/A	Landing Length (in)	N/A	N/A	DWS Provided?	N/A
N/A	Landing Width (in)	N/A	N/A	DWS Contrast?	N/A
N/A	Landing Slope (%)	N/A	N/A	DWS Length (in)	N/A
N/A	Landing X Slope (%)	N/A	N/A	DWS Full Width?	N/A
N/A	Landing Curb? (Y/N)	N/A	N/A	DWS Offset (in)	N/A
N/A	Shared Landing?	N/A			
N/A	Gutter Ponding?	N/A	N/A	Gutter Slope (%)	N/A
N/A	Gutter Lip Ht (in)	N/A	N/A	Gutter X Slope (%)	N/A
N/A	Painted X Walk1?	No	N/A	Painted X Walk2?	No
	X Walk 1 Direction	To S		X Walk 2 Direction	To E
N/A	X Walk 1 Width (in)	N/A	N/A	X Walk 2 Width (in)	N/A
	X Walk 1 Slope (%)	4.6		X Walk 2 Slope (%)	3.1
	X Walk 1 X Slope (%)	2.3		X Walk 2 X Slope (%)	2.6

N/A	Ramp inside XWalk1?	N/A	N/A	Ramp inside XWalk2?	N/A
	Road Slope (%)	2.1	N/A	Clear Space?	N/A
	Road X Slope (%)	6.8	N/A	Clear Space to XWalk (in)	N/A
N/A	Any Obstructions?	N/A	N/A	Storm Grate/Utility Hazard?	N/A
	Obstruction Type			Storm Grate/Utility Type	
		N/A			N/A
			Yes	Surface Condition? (G/P)	Good

Remove & Replace Curb Ramp With Two New Directional Ramps or Equivalent.
