# Access Compliance Report
Public Rights-of-Way
(Curb Ramps)

Intersection ID: 10024600	Main Street: DANIELLE_CHRISTINA_CT	Cross Street: N/A	Location:	NW
ADA ID: CC37A0E365CE	Ramp Type: BlendTrans2	Initial Pass/Fail: Pass	Overall Compliance: No	Severity Score: 12.75

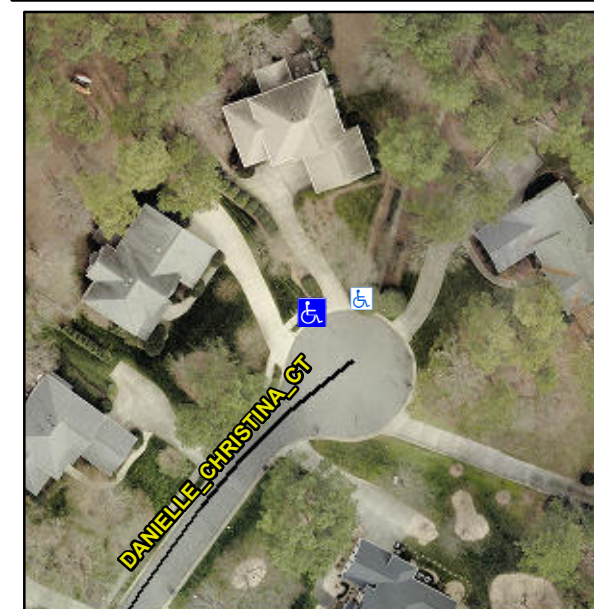
Not Found, R304.5.3, R305.2, R302.7.2, R304.5.4

Compliance	Description	Data	Compliance	Description	Data
N/A	Ramp Length (in)	77.0	Yes	BlendTrans Slope (%)	5.0
Yes	Ramp Width (in)	48.0	No	BlendTrans XSlope (%)	4.5
N/A	Flare Type LT	Sloped	N/A	Flare Type RT	Sloped
N/A	Flare Slope LT (%)	3.0	N/A	Flare Slope RT (%)	5.9
N/A	Flare Traversable LT?	No	N/A	Flare Traversable RT?	No
N/A	Landing Length (in)	N/A	Yes	DWS Provided?	Yes
N/A	Landing Width (in)	N/A	Yes	DWS Contrast?	Yes
N/A	Landing Slope (%)	N/A	Yes	DWS Length (in)	24.0
N/A	Landing X Slope (%)	N/A	Yes	DWS Full Width?	Yes
N/A	Landing Curb? (Y/N)	No	No	DWS Offset (in)	2.5
N/A	Shared Landing?	No			
Yes	Gutter Ponding?	No	No	Gutter Slope (%)	5.7
No	Gutter Lip Ht (in)	0.5	No	Gutter X Slope (%)	2.6
N/A	Painted X Walk1?	No	N/A	Painted X Walk2?	N/A
	X Walk 1 Direction	To S		X Walk 2 Direction	N/A
	X Walk 1 Width (in)	N/A		X Walk 2 Width (in)	N/A
	X Walk 1 Slope (%)	1.4		X Walk 2 Slope (%)	N/A
	X Walk 1 X Slope (%)	0.5		X Walk 2 X Slope (%)	N/A

N/A	Ramp inside XWalk1?	N/A	N/A	Ramp inside XWalk2?	N/A
	Road Slope (%)	0.5		Clear Space?	Yes
	Road X Slope (%)	1.4	N/A	Clear Space to XWalk (in)	N/A
Yes	Any Obstructions?	No	Yes	Storm Grate/Utility Hazard?	No
	Obstruction Type			Storm Grate/Utility Type	
		N/A			N/A
			Yes	Surface Condition? (G/P)	Good
			No	Curb Slope (%)	9.1

Remove & Replace Curb Ramp With Two New Directional Ramps or Equivalent. Remove & Replace Gutter.
