Access Compliance Report
Public Rights-of-Way
(Curb Ramps)

Intersection ID: 52551	Main Street: KRISTENS_MARE_DR	Cross Street: ARDREY_WOODS_DR	Location: W
ADA ID: CD11871F1AB0	Ramp Type: PerpDiag	Initial Pass/Fail: Fail	Overall Compliance: No	Severity Score: 1.25

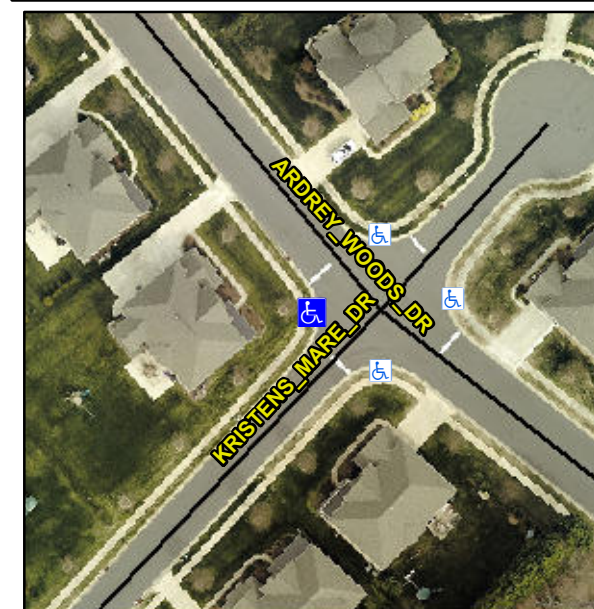
Not Found, R304.5.3

Compliance	Description	Data	Compliance	Description	Data
N/A	Ramp Length (in)	48.0	Yes	Ramp Slope (%)	6.9
Yes	Ramp Width (in)	48.0	No	Ramp XSlope (%)	2.4
N/A	Flare Type LT	N/A	N/A	Flare Type RT	N/A
N/A	Flare Slope LT (%)	N/A	N/A	Flare Slope RT (%)	N/A
N/A	Flare Traversable LT?	N/A	N/A	Flare Traversable RT?	N/A
N/A	Landing Length (in)	N/A	N/A	DWS Provided?	N/A
N/A	Landing Width (in)	N/A	N/A	DWS Contrast?	N/A
N/A	Landing Slope (%)	N/A	N/A	DWS Length (in)	N/A
N/A	Landing X Slope (%)	N/A	N/A	DWS Full Width?	N/A
N/A	Landing Curb? (Y/N)	N/A	N/A	DWS Offset (in)	N/A
N/A	Shared Landing?	N/A			
N/A	Gutter Ponding?	N/A	N/A	Gutter Slope (%)	N/A
N/A	Gutter Lip Ht (in)	N/A	N/A	Gutter X Slope (%)	N/A
N/A	Painted X Walk1?	No	N/A	Painted X Walk2?	No
	X Walk 1 Direction	To SE		X Walk 2 Direction	To NE
N/A	X Walk 1 Width (in)	N/A	N/A	X Walk 2 Width (in)	N/A
	X Walk 1 Slope (%)	1.2		X Walk 2 Slope (%)	1.7
	X Walk 1 X Slope (%)	1.9		X Walk 2 X Slope (%)	2.8

Remove & Replace Curb Ramp With Two New Directional Ramps or Equivalent.
