Access Compliance Report
Public Rights-of-Way
(Curb Ramps)

Intersection ID: 5646	Main Street: MCCULLOUGH_DR	Cross Street: COLLINS-AIKMAN_DR	Location: SE
ADA ID: CDD58F6C3157	Ramp Type: PerpDiag	Initial Pass/Fail: Fail	Overall Compliance: No	Severity Score: 22.5

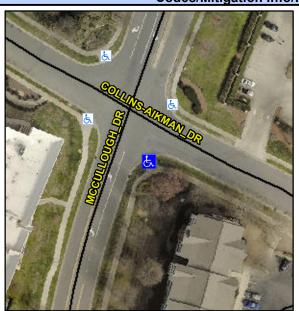
Not Found, R304.5.1, R304.2.2, R304.5.3

Compliance	Description	Data	Compliance	Description	Data
N/A	Ramp Length (in)	44.0	No	Ramp Slope (%)	9.5
No	Ramp Width (in)	46.0	No	Ramp XSlope (%)	4.4
N/A	Flare Type LT	N/A	N/A	Flare Type RT	N/A
N/A	Flare Slope LT (%)	N/A	N/A	Flare Slope RT (%)	N/A
N/A	Flare Traversable LT?	N/A	N/A	Flare Traversable RT?	N/A
N/A	Landing Length (in)	N/A	N/A	DWS Provided?	N/A
N/A	Landing Width (in)	N/A	N/A	DWS Contrast?	N/A
N/A	Landing Slope (%)	N/A	N/A	DWS Length (in)	N/A
N/A	Landing X Slope (%)	N/A	N/A	DWS Full Width?	N/A
N/A	Landing Curb? (Y/N)	N/A	N/A	DWS Offset (in)	N/A
N/A	Shared Landing?	N/A			
N/A	Gutter Ponding?	N/A	N/A	Gutter Slope (%)	N/A
N/A	Gutter Lip Ht (in)	N/A	N/A	Gutter X Slope (%)	N/A
N/A	Painted X Walk1?	No	N/A	Painted X Walk2?	No
	X Walk 1 Direction	To NE		X Walk 2 Direction	To NW
N/A	X Walk 1 Width (in)	N/A	N/A	X Walk 2 Width (in)	N/A
	X Walk 1 Slope (%)	0.4		X Walk 2 Slope (%)	6.9
	X Walk 1 X Slope (%)	5.0		X Walk 2 X Slope (%)	0.7

N/A	Ramp inside XWalk1?	N/A	N/A	Ramp inside XWalk2?	N/A
	Road Slope (%)	3.9	N/A	Clear Space?	N/A
	Road X Slope (%)	4.9	N/A	Clear Space to XWalk (in)	N/A
N/A	Any Obstructions?	N/A	N/A	Storm Grate/Utility Hazard?	N/A
	Obstruction Type			Storm Grate/Utility Type	
N/A					N/A
			Yes	Surface Condition? (G/P)	Good

Remove & Replace Curb Ramp With Two New Directional Ramps or Equivalent.
