Access Compliance Report
Public Rights-of-Way
(Curb Ramps)

Intersection ID: 12333	**Main Street: N_BREVARD_ST**	**Cross Street: E_7TH_ST**	**Location: W**
ADA ID: CF820B3EBA43	**Ramp Type: Perp**	**Initial Pass/Fail: Pass**	**Overall Compliance: No** **Severity Score: 0**

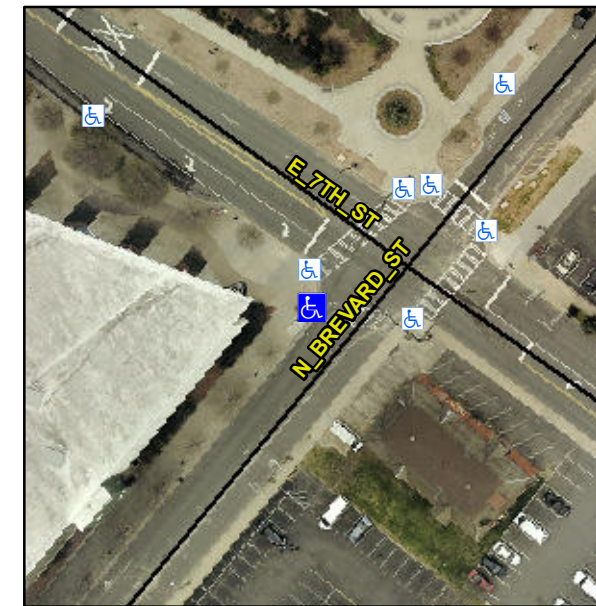
Not Found, R304.2.2-Perp, R304.3.2-Para, R304.5.3

Compliance	Description	Data	Compliance	Description	Data
N/A	Ramp Length (in)	60.0	Yes	Ramp Slope (%)	7.0
Yes	Ramp Width (in)	48.0	Yes	Ramp XSlope (%)	0.3
N/A	Flare Type LT	Sloped	N/A	Flare Type RT	N/A
N/A	Flare Slope LT (%)	3.5	Yes	Flare Slope RT (%)	5.1
N/A	Flare Traversable LT?	No	N/A	Flare Traversable RT?	Yes
Yes	Landing Length (in)	48.0	Yes	DWS Provided?	Yes
Yes	Landing Width (in)	48.0	Yes	DWS Contrast?	Yes
No	Landing Slope (%)	2.9	Yes	DWS Length (in)	24.0
No	Landing X Slope (%)	2.1	Yes	DWS Full Width?	Yes
N/A	Landing Curb? (Y/N)	No	Yes	DWS Offset (in)	0.0
N/A	Shared Landing?	No			
Yes	Gutter Ponding?	No	Yes	Gutter Slope (%)	1.9
Yes	Gutter Lip Ht (in)	0.0	Yes	Gutter X Slope (%)	0.1
N/A	Painted X Walk1?	Yes	N/A	Painted X Walk2?	N/A
	X Walk 1 Direction	To SE		X Walk 2 Direction	N/A
N/A	X Walk 1 Width (in)	110.0	N/A	X Walk 2 Width (in)	N/A
	X Walk 1 Slope (%)	2.5		X Walk 2 Slope (%)	N/A
	X Walk 1 X Slope (%)	0.4		X Walk 2 X Slope (%)	N/A

Yes	Ramp inside XWalk1?	Yes	N/A	Ramp inside XWalk2?	N/A
	Road Slope (%)	N/A	N/A	Clear Space?	Yes
	Road X Slope (%)	N/A	N/A	Clear Space to XWalk (in)	N/A
Yes	Any Obstructions?	No	Yes	Storm Grate/Utility Hazard?	No
	Obstruction Type			Storm Grate/Utility Type	
		N/A			N/A
			Yes	Surface Condition? (G/P)	Good

Remove & Replace Entire Ramp.

Total Cost: $ 1850.00
