Access Compliance Report
Public Rights-of-Way
(Curb Ramps)

Intersection ID: 2850	Main Street: BEAUVISTA_DR	Cross Street: PECAN_COVE_LN	Location:	NW
ADA ID: D088B75FD555	Ramp Type: PerpDiag	Initial Pass/Fail: Fail	Overall Compliance: No	Severity Score: 22.5

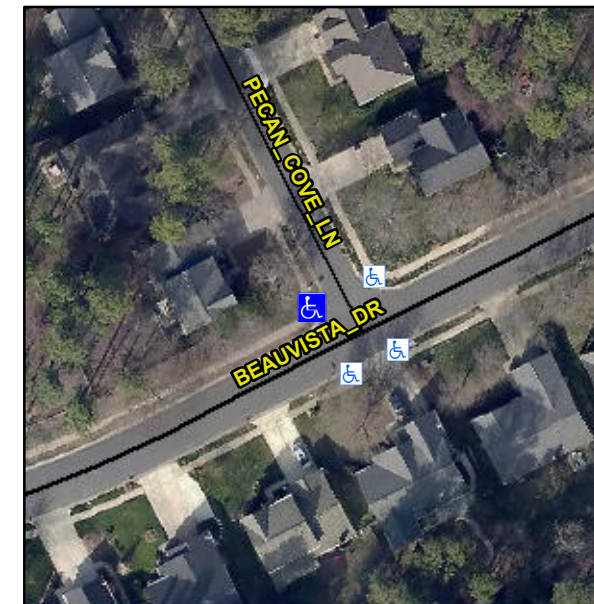
Not Found, R304.5.1, R304.2.2, R304.5.3

Compliance	Description	Data	Compliance	Description	Data
N/A	Ramp Length (in)	57.0	No	Ramp Slope (%)	10.4
No	Ramp Width (in)	38.0	No	Ramp XSlope (%)	4.1
N/A	Flare Type LT	N/A	N/A	Flare Type RT	N/A
N/A	Flare Slope LT (%)	N/A	N/A	Flare Slope RT (%)	N/A
N/A	Flare Traversable LT?	N/A	N/A	Flare Traversable RT?	N/A
N/A	Landing Length (in)	N/A	N/A	DWS Provided?	N/A
N/A	Landing Width (in)	N/A	N/A	DWS Contrast?	N/A
N/A	Landing Slope (%)	N/A	N/A	DWS Length (in)	N/A
N/A	Landing X Slope (%)	N/A	N/A	DWS Full Width?	N/A
N/A	Landing Curb? (Y/N)	N/A	N/A	DWS Offset (in)	N/A
N/A	Shared Landing?	N/A			
N/A	Gutter Ponding?	N/A	N/A	Gutter Slope (%)	N/A
N/A	Gutter Lip Ht (in)	N/A	N/A	Gutter X Slope (%)	N/A
N/A	Painted X Walk1?	No	N/A	Painted X Walk2?	No
	X Walk 1 Direction	To S		X Walk 2 Direction	To E
N/A	X Walk 1 Width (in)	N/A	N/A	X Walk 2 Width (in)	N/A
	X Walk 1 Slope (%)	6.4		X Walk 2 Slope (%)	2.0
	X Walk 1 X Slope (%)	0.8		X Walk 2 X Slope (%)	3.1

Remove & Replace Curb Ramp With Two New Directional Ramps or Equivalent.
