# Access Compliance Report
Public Rights-of-Way
(Curb Ramps)

Intersection ID: 3626   **Main Street: LEXINGTON_APPROACH_DR**   **Cross Street: MALLARD_CREEK_RD**   **Location:** **E**

ADA ID: D0B72CCA114C   **Ramp Type: Perp**   **Initial Pass/Fail: Fail**   **Overall Compliance: No**   **Severity Score: 21.25**

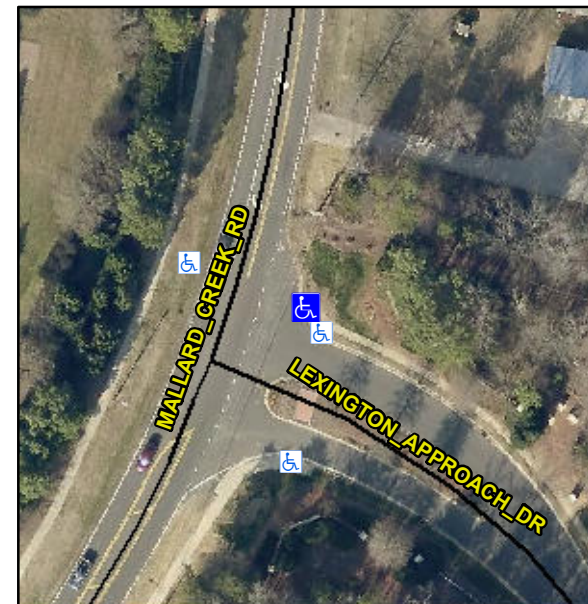
R304.5.1, R304.2.2

Compliance	Description	Data	Compliance	Description	Data
N/A	Ramp Length (in)	45.0	No	Ramp Slope (%)	10.6
No	Ramp Width (in)	36.0	Yes	Ramp XSlope (%)	1.3
N/A	Flare Type LT	N/A	N/A	Flare Type RT	N/A
N/A	Flare Slope LT (%)	N/A	N/A	Flare Slope RT (%)	N/A
N/A	Flare Traversable LT?	N/A	N/A	Flare Traversable RT?	N/A
N/A	Landing Length (in)	N/A	N/A	DWS Provided?	N/A
N/A	Landing Width (in)	N/A	N/A	DWS Contrast?	N/A
N/A	Landing Slope (%)	N/A	N/A	DWS Length (in)	N/A
N/A	Landing X Slope (%)	N/A	N/A	DWS Full Width?	N/A
N/A	Landing Curb? (Y/N)	N/A	N/A	DWS Offset (in)	N/A
N/A	Shared Landing?	N/A			
N/A	Gutter Ponding?	N/A	N/A	Gutter Slope (%)	N/A
N/A	Gutter Lip Ht (in)	N/A	N/A	Gutter X Slope (%)	N/A
N/A	Painted X Walk1?	No	N/A	Painted X Walk2?	N/A
	X Walk 1 Direction	To NW		X Walk 2 Direction	N/A
N/A	X Walk 1 Width (in)	N/A	N/A	X Walk 2 Width (in)	N/A
	X Walk 1 Slope (%)	7.5		X Walk 2 Slope (%)	N/A
	X Walk 1 X Slope (%)	2.8		X Walk 2 X Slope (%)	N/A

Remove & Replace Entire Ramp.
