Access Compliance Report
Public Rights-of-Way
(Curb Ramps)

Intersection ID: 3559	Main Street: PERIMETER_PY	Cross Street: W_W_T_HARRIS_BV	Location:	SE
ADA ID: D0C2B037BFF6	Ramp Type: Perp	Initial Pass/Fail: Fail	Overall Compliance: No	Severity Score: 13.75

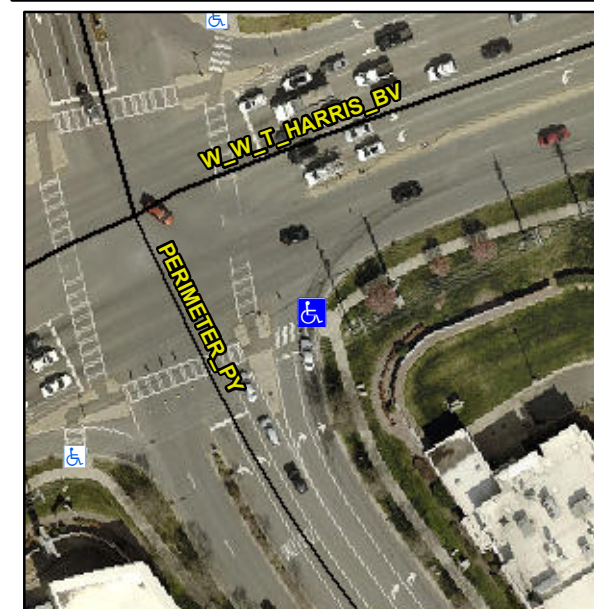
Not Found, R304.2.2

Compliance	Description	Data	Compliance	Description	Data
N/A	Ramp Length (in)	59.0	No	Ramp Slope (%)	8.4
Yes	Ramp Width (in)	48.0	Yes	Ramp XSlope (%)	2.7
N/A	Flare Type LT	N/A	N/A	Flare Type RT	N/A
N/A	Flare Slope LT (%)	N/A	N/A	Flare Slope RT (%)	N/A
N/A	Flare Traversable LT?	N/A	N/A	Flare Traversable RT?	N/A
N/A	Landing Length (in)	N/A	N/A	DWS Provided?	N/A
N/A	Landing Width (in)	N/A	N/A	DWS Contrast?	N/A
N/A	Landing Slope (%)	N/A	N/A	DWS Length (in)	N/A
N/A	Landing X Slope (%)	N/A	N/A	DWS Full Width?	N/A
N/A	Landing Curb? (Y/N)	N/A	N/A	DWS Offset (in)	N/A
N/A	Shared Landing?	N/A			
N/A	Gutter Ponding?	N/A	N/A	Gutter Slope (%)	N/A
N/A	Gutter Lip Ht (in)	N/A	N/A	Gutter X Slope (%)	N/A
N/A	Painted X Walk1?	Yes	N/A	Painted X Walk2?	N/A
	X Walk 1 Direction	To NW		X Walk 2 Direction	N/A
N/A	X Walk 1 Width (in)	120.0	N/A	X Walk 2 Width (in)	N/A
	X Walk 1 Slope (%)	1.3		X Walk 2 Slope (%)	N/A
	X Walk 1 X Slope (%)	4.2		X Walk 2 X Slope (%)	N/A

Remove & Replace Entire Ramp.
