Access Compliance Report
Public Rights-of-Way
(Curb Ramps)

Intersection ID: 27409	Main Street: VALLEY_SPRING_DR	Cross Street: WOLF_DEN_LN	Location:	W
ADA ID: D0CE24D1C0D7	Ramp Type: PerpDiag	Initial Pass/Fail: Fail	Overall Compliance: No	Severity Score: 25

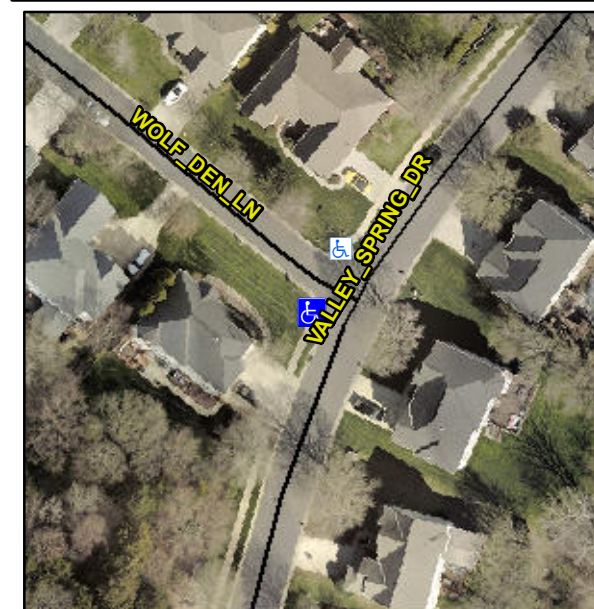
R304.2.2, R304.5.3

Compliance	Description	Data	Compliance	Description	Data
N/A	Ramp Length (in)	51.5	No	Ramp Slope (%)	9.0
Yes	Ramp Width (in)	48.0	No	Ramp XSlope (%)	6.3
N/A	Flare Type LT	N/A	N/A	Flare Type RT	N/A
N/A	Flare Slope LT (%)	N/A	N/A	Flare Slope RT (%)	N/A
N/A	Flare Traversable LT?	N/A	N/A	Flare Traversable RT?	N/A
N/A	Landing Length (in)	N/A	N/A	DWS Provided?	N/A
N/A	Landing Width (in)	N/A	N/A	DWS Contrast?	N/A
N/A	Landing Slope (%)	N/A	N/A	DWS Length (in)	N/A
N/A	Landing X Slope (%)	N/A	N/A	DWS Full Width?	N/A
N/A	Landing Curb? (Y/N)	N/A	N/A	DWS Offset (in)	N/A
N/A	Shared Landing?	N/A			
N/A	Gutter Ponding?	N/A	N/A	Gutter Slope (%)	N/A
N/A	Gutter Lip Ht (in)	N/A	N/A	Gutter X Slope (%)	N/A
N/A	Painted X Walk1?	No	N/A	Painted X Walk2?	No
	X Walk 1 Direction	To SE		X Walk 2 Direction	To NE
N/A	X Walk 1 Width (in)	N/A	N/A	X Walk 2 Width (in)	N/A
	X Walk 1 Slope (%)	5.7		X Walk 2 Slope (%)	3.4
	X Walk 1 X Slope (%)	4.1		X Walk 2 X Slope (%)	3.0

Remove & Replace Curb Ramp With Two New Directional Ramps or Equivalent.
