Access Compliance Report
Public Rights-of-Way
(Curb Ramps)

Intersection ID: 10034377	**Main Street:** CAMERON_VALLEY_PY	**Cross Street:** PHILLIPS_PL	**Location:** SW
ADA ID: D0D78CD20C64	**Ramp Type:** BlendTrans1	**Initial Pass/Fail:** Fail **Overall Compliance:** No	**Severity Score:** 1.25

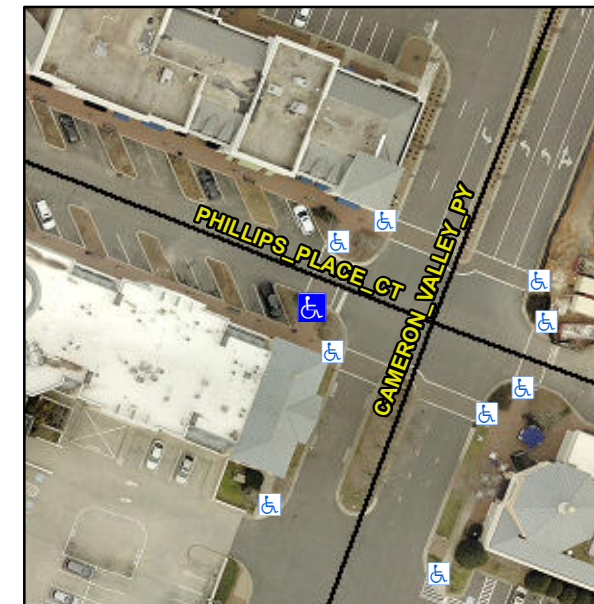
XWALK PAVERS

R304.5.3

Compliance	Description	Data	Compliance	Description	Data
N/A	Ramp Length (in)	48.0	Yes	BlendTrans Slope (%)	1.6
Yes	Ramp Width (in)	48.0	No	BlendTrans XSlope (%)	4.7
N/A	Flare Type LT	N/A	N/A	Flare Type RT	N/A
N/A	Flare Slope LT (%)	N/A	N/A	Flare Slope RT (%)	N/A
N/A	Flare Traversable LT?	N/A	N/A	Flare Traversable RT?	N/A
N/A	Landing Length (in)	N/A	N/A	DWS Provided?	N/A
N/A	Landing Width (in)	N/A	N/A	DWS Contrast?	N/A
N/A	Landing Slope (%)	N/A	N/A	DWS Length (in)	N/A
N/A	Landing X Slope (%)	N/A	N/A	DWS Full Width?	N/A
N/A	Landing Curb? (Y/N)	N/A	N/A	DWS Offset (in)	N/A
N/A	Shared Landing?	N/A			
N/A	Gutter Ponding?	N/A	N/A	Gutter Slope (%)	N/A
N/A	Gutter Lip Ht (in)	N/A	N/A	Gutter X Slope (%)	N/A
N/A	Painted X Walk1?	Yes	N/A	Painted X Walk2?	N/A
	X Walk 1 Direction	To NW		X Walk 2 Direction	N/A
	X Walk 1 Width (in)	170.0		X Walk 2 Width (in)	N/A
	X Walk 1 Slope (%)	0.9		X Walk 2 Slope (%)	N/A
	X Walk 1 X Slope (%)	2.8		X Walk 2 X Slope (%)	N/A

Remove & Replace Curb Ramp With Two New Directional Ramps or Equivalent.
