# Access Compliance Report
Public Rights-of-Way
(Curb Ramps)

Intersection ID: 23166	Main Street: LAUREL_POINTE_WY	Cross Street: LAUREL_VIEW_DR	Location:	SW
ADA ID: D105AAFDE798	Ramp Type: Perp	Initial Pass/Fail: Fail	Overall Compliance: No	Severity Score: 12.5

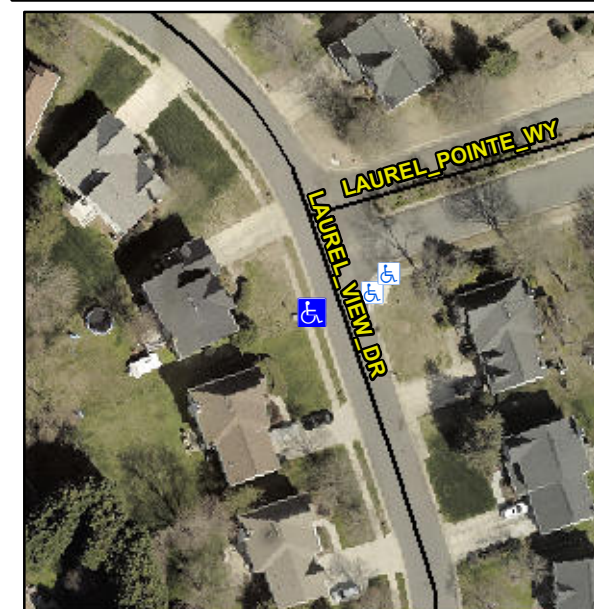
Not Found, R304.2.2

Compliance	Description	Data	Compliance	Description	Data
N/A	Ramp Length (in)	47.0	No	Ramp Slope (%)	8.8
Yes	Ramp Width (in)	48.0	Yes	Ramp XSlope (%)	1.5
N/A	Flare Type LT	N/A	N/A	Flare Type RT	N/A
N/A	Flare Slope LT (%)	N/A	N/A	Flare Slope RT (%)	N/A
N/A	Flare Traversable LT?	N/A	N/A	Flare Traversable RT?	N/A
N/A	Landing Length (in)	N/A	N/A	DWS Provided?	N/A
N/A	Landing Width (in)	N/A	N/A	DWS Contrast?	N/A
N/A	Landing Slope (%)	N/A	N/A	DWS Length (in)	N/A
N/A	Landing X Slope (%)	N/A	N/A	DWS Full Width?	N/A
N/A	Landing Curb? (Y/N)	N/A	N/A	DWS Offset (in)	N/A
N/A	Shared Landing?	N/A			
N/A	Gutter Ponding?	N/A	N/A	Gutter Slope (%)	N/A
N/A	Gutter Lip Ht (in)	N/A	N/A	Gutter X Slope (%)	N/A
N/A	Painted X Walk1?	No	N/A	Painted X Walk2?	N/A
	X Walk 1 Direction	To E		X Walk 2 Direction	N/A
N/A	X Walk 1 Width (in)	N/A	N/A	X Walk 2 Width (in)	N/A
	X Walk 1 Slope (%)	2.5		X Walk 2 Slope (%)	N/A
	X Walk 1 X Slope (%)	0.7		X Walk 2 X Slope (%)	N/A

Remove & Replace Entire Ramp.
