Access Compliance Report
Public Rights-of-Way
(Curb Ramps)

Intersection ID: 17739	**Main Street:** E_WOODLAWN_RD	**Cross Street:** SOUTH_BV	**Location:**	**NE**
ADA ID: D304D4E51CBD	**Ramp Type:** Perp	**Initial Pass/Fail:** Fail	**Overall Compliance:** No	**Severity Score:** 26.25

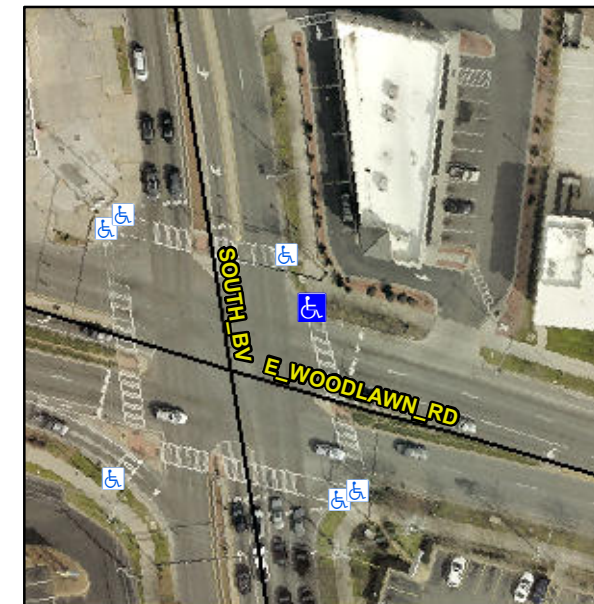
R304.2.2, R304.5.3

Compliance	Description	Data	Compliance	Description	Data
N/A	Ramp Length (in)	80.0	No	Ramp Slope (%)	12.4
Yes	Ramp Width (in)	48.0	No	Ramp XSlope (%)	2.2
N/A	Flare Type LT	N/A	N/A	Flare Type RT	N/A
N/A	Flare Slope LT (%)	N/A	N/A	Flare Slope RT (%)	N/A
N/A	Flare Traversable LT?	N/A	N/A	Flare Traversable RT?	N/A
N/A	Landing Length (in)	N/A	N/A	DWS Provided?	N/A
N/A	Landing Width (in)	N/A	N/A	DWS Contrast?	N/A
N/A	Landing Slope (%)	N/A	N/A	DWS Length (in)	N/A
N/A	Landing X Slope (%)	N/A	N/A	DWS Full Width?	N/A
N/A	Landing Curb? (Y/N)	N/A	N/A	DWS Offset (in)	N/A
N/A	Shared Landing?	N/A			
N/A	Gutter Ponding?	N/A	N/A	Gutter Slope (%)	N/A
N/A	Gutter Lip Ht (in)	N/A	N/A	Gutter X Slope (%)	N/A
N/A	Painted X Walk1?	Yes	N/A	Painted X Walk2?	N/A
	X Walk 1 Direction	To S		X Walk 2 Direction	N/A
N/A	X Walk 1 Width (in)	92.0	N/A	X Walk 2 Width (in)	N/A
	X Walk 1 Slope (%)	3.6		X Walk 2 Slope (%)	N/A
	X Walk 1 X Slope (%)	0.7		X Walk 2 X Slope (%)	N/A

Remove & Replace Entire Ramp.
