Access Compliance Report
Public Rights-of-Way
(Curb Ramps)

Intersection ID: 27530	Main Street: BALLANTYNE_COMMONS_PY Cross Street: BALLANTYNE_FOREST_DR	Location:	SE
ADA ID: D3AD5C705493	Ramp Type: Perp	Initial Pass/Fail: Fail	Overall Compliance: No	Severity Score: 13.75

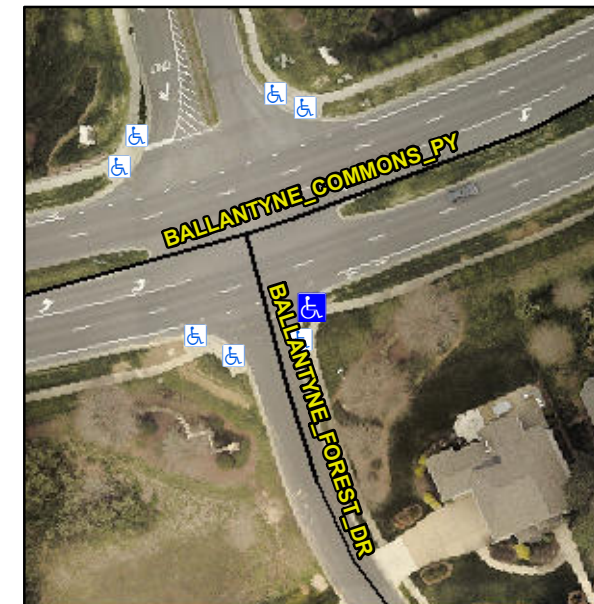
R304.2.2, R304.5.3

Compliance	Description	Data	Compliance	Description	Data
N/A	Ramp Length (in)	45.0	No	Ramp Slope (%)	8.6
Yes	Ramp Width (in)	51.0	No	Ramp XSlope (%)	3.7
N/A	Flare Type LT	N/A	N/A	Flare Type RT	N/A
N/A	Flare Slope LT (%)	N/A	N/A	Flare Slope RT (%)	N/A
N/A	Flare Traversable LT?	N/A	N/A	Flare Traversable RT?	N/A
N/A	Landing Length (in)	N/A	N/A	DWS Provided?	N/A
N/A	Landing Width (in)	N/A	N/A	DWS Contrast?	N/A
N/A	Landing Slope (%)	N/A	N/A	DWS Length (in)	N/A
N/A	Landing X Slope (%)	N/A	N/A	DWS Full Width?	N/A
N/A	Landing Curb? (Y/N)	N/A	N/A	DWS Offset (in)	N/A
N/A	Shared Landing?	N/A			
N/A	Gutter Ponding?	N/A	N/A	Gutter Slope (%)	N/A
N/A	Gutter Lip Ht (in)	N/A	N/A	Gutter X Slope (%)	N/A
N/A	Painted X Walk1?	No	N/A	Painted X Walk2?	N/A
	X Walk 1 Direction	To NE		X Walk 2 Direction	N/A
N/A	X Walk 1 Width (in)	N/A	N/A	X Walk 2 Width (in)	N/A
	X Walk 1 Slope (%)	5.2		X Walk 2 Slope (%)	N/A
	X Walk 1 X Slope (%)	1.1		X Walk 2 X Slope (%)	N/A

Remove & Replace Entire Ramp.
