Access Compliance Report
Public Rights-of-Way
(Curb Ramps)

Intersection ID: 44932	Main Street: NATHAN_DR	Cross Street: BRUMIT_LN	Location:	SE
ADA ID: D41929A04F7F	Ramp Type: PerpDiag	Initial Pass/Fail: Fail	Overall Compliance: No	Severity Score: 26.25

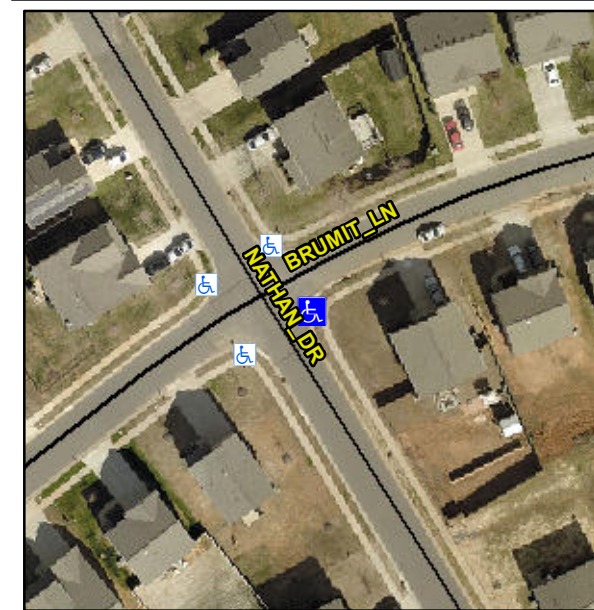
Not Found, R304.2.2, R304.5.3

Compliance	Description	Data	Compliance	Description	Data
N/A	Ramp Length (in)	50.5	No	Ramp Slope (%)	13.1
Yes	Ramp Width (in)	48.0	No	Ramp XSlope (%)	2.2
N/A	Flare Type LT	N/A	N/A	Flare Type RT	N/A
N/A	Flare Slope LT (%)	N/A	N/A	Flare Slope RT (%)	N/A
N/A	Flare Traversable LT?	N/A	N/A	Flare Traversable RT?	N/A
N/A	Landing Length (in)	N/A	N/A	DWS Provided?	N/A
N/A	Landing Width (in)	N/A	N/A	DWS Contrast?	N/A
N/A	Landing Slope (%)	N/A	N/A	DWS Length (in)	N/A
N/A	Landing X Slope (%)	N/A	N/A	DWS Full Width?	N/A
N/A	Landing Curb? (Y/N)	N/A	N/A	DWS Offset (in)	N/A
N/A	Shared Landing?	N/A			
N/A	Gutter Ponding?	N/A	N/A	Gutter Slope (%)	N/A
N/A	Gutter Lip Ht (in)	N/A	N/A	Gutter X Slope (%)	N/A
N/A	Painted X Walk1?	No	N/A	Painted X Walk2?	No
	X Walk 1 Direction	To N		X Walk 2 Direction	To SW
N/A	X Walk 1 Width (in)	N/A	N/A	X Walk 2 Width (in)	N/A
	X Walk 1 Slope (%)	0.5		X Walk 2 Slope (%)	2.0
	X Walk 1 X Slope (%)	1.4		X Walk 2 X Slope (%)	0.2

Remove & Replace Curb Ramp With Two New Directional Ramps or Equivalent.
