# Access Compliance Report
# Public Rights-of-Way
# (Curb Ramps)

| Intersection ID: 23437 | Main Street: TRYON_ST | Cross Street: MOSS_LN | Location: W |
| ADA ID: D4B7C8984A9E | Ramp Type: MedianPerp | Initial Pass/Fail: Fail | Overall Compliance: No | Severity Score: 12.5 |

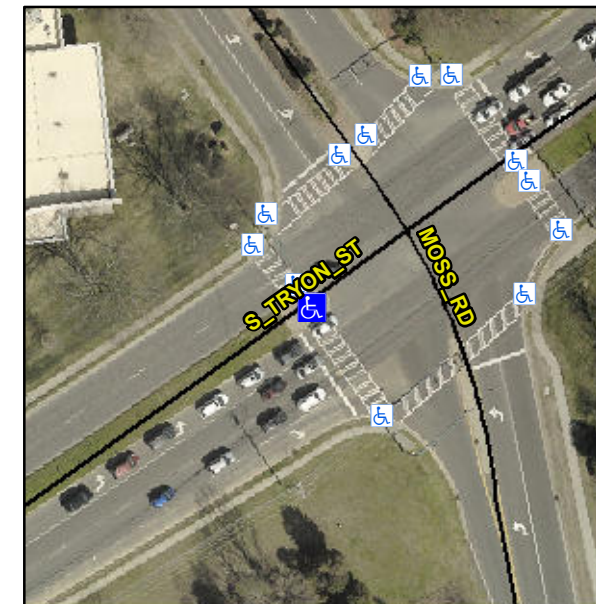
**Not Found, R304.2.2**

| Compliance | Description | Data | Compliance | Description | Data |
|---|---|---|---|---|---|
| N/A | Ramp Length (in) | 48.0 | No | Ramp Slope (%) | 9.8 |

**Remove & Replace Entire Ramp.**
