Access Compliance Report
Public Rights-of-Way
(Curb Ramps)

Intersection ID: 10015635	Main Street: HARRIS_CORNERS_PY	Cross Street: N/A	Location: S
ADA ID: D55B0D81CD28	Ramp Type: PerpDiag	Initial Pass/Fail: Fail	Overall Compliance: No	Severity Score: 8.75

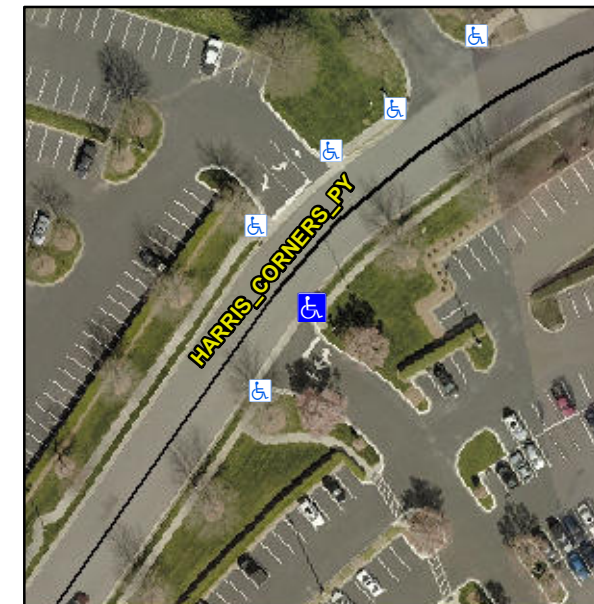
R304.5.1

Compliance	Description	Data	Compliance	Description	Data
N/A	Ramp Length (in)	66.0	Yes	Ramp Slope (%)	5.3
No	Ramp Width (in)	44.0	Yes	Ramp XSlope (%)	0.2
N/A	Flare Type LT	N/A	N/A	Flare Type RT	N/A
N/A	Flare Slope LT (%)	N/A	N/A	Flare Slope RT (%)	N/A
N/A	Flare Traversable LT?	N/A	N/A	Flare Traversable RT?	N/A
N/A	Landing Length (in)	N/A	N/A	DWS Provided?	N/A
N/A	Landing Width (in)	N/A	N/A	DWS Contrast?	N/A
N/A	Landing Slope (%)	N/A	N/A	DWS Length (in)	N/A
N/A	Landing X Slope (%)	N/A	N/A	DWS Full Width?	N/A
N/A	Landing Curb? (Y/N)	N/A	N/A	DWS Offset (in)	N/A
N/A	Shared Landing?	N/A			
N/A	Gutter Ponding?	N/A	N/A	Gutter Slope (%)	N/A
N/A	Gutter Lip Ht (in)	N/A	N/A	Gutter X Slope (%)	N/A
N/A	Painted X Walk1?	No	N/A	Painted X Walk2?	No
	X Walk 1 Direction	To NW		X Walk 2 Direction	To SW
N/A	X Walk 1 Width (in)	N/A	N/A	X Walk 2 Width (in)	N/A
	X Walk 1 Slope (%)	2.1		X Walk 2 Slope (%)	0.6
	X Walk 1 X Slope (%)	0.2		X Walk 2 X Slope (%)	1.3

Remove & Replace Curb Ramp With Two New Directional Ramps or Equivalent.
