Access Compliance Report
Public Rights-of-Way
(Curb Ramps)

Intersection ID: 28626	Main Street: MILLERS_CREEK_LN	Cross Street: STUARTS_DRAFT_CT	Location:	SW
ADA ID: D5F21147616B	Ramp Type: PerpDiag	Initial Pass/Fail: Fail	Overall Compliance: No	Severity Score: 22.5

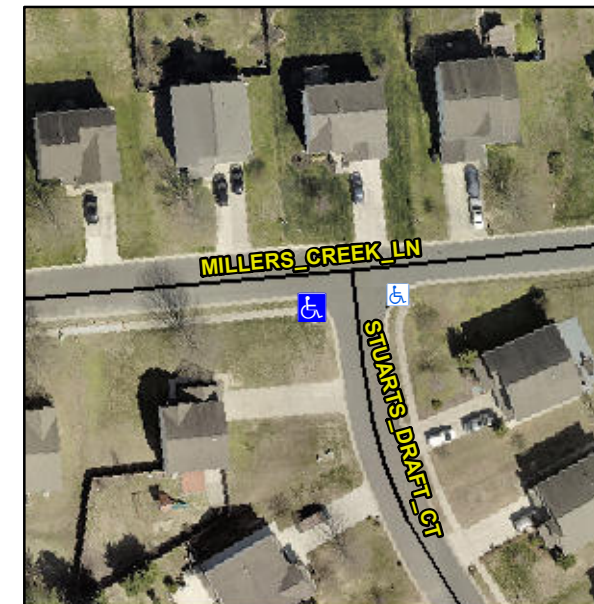
R304.5.1, R304.2.2, R304.5.3

Compliance	Description	Data	Compliance	Description	Data
N/A	Ramp Length (in)	48.3	No	Ramp Slope (%)	8.5
No	Ramp Width (in)	39.0	No	Ramp XSlope (%)	4.6
N/A	Flare Type LT	N/A	N/A	Flare Type RT	N/A
N/A	Flare Slope LT (%)	N/A	N/A	Flare Slope RT (%)	N/A
N/A	Flare Traversable LT?	N/A	N/A	Flare Traversable RT?	N/A
N/A	Landing Length (in)	N/A	N/A	DWS Provided?	N/A
N/A	Landing Width (in)	N/A	N/A	DWS Contrast?	N/A
N/A	Landing Slope (%)	N/A	N/A	DWS Length (in)	N/A
N/A	Landing X Slope (%)	N/A	N/A	DWS Full Width?	N/A
N/A	Landing Curb? (Y/N)	N/A	N/A	DWS Offset (in)	N/A
N/A	Shared Landing?	N/A			
N/A	Gutter Ponding?	N/A	N/A	Gutter Slope (%)	N/A
N/A	Gutter Lip Ht (in)	N/A	N/A	Gutter X Slope (%)	N/A
N/A	Painted X Walk1?	No	N/A	Painted X Walk2?	No
	X Walk 1 Direction	To E		X Walk 2 Direction	To N
N/A	X Walk 1 Width (in)	N/A	N/A	X Walk 2 Width (in)	N/A
	X Walk 1 Slope (%)	2.8		X Walk 2 Slope (%)	3.0
	X Walk 1 X Slope (%)	4.3		X Walk 2 X Slope (%)	1.2

Remove & Replace Curb Ramp With Two New Directional Ramps or Equivalent.
