Access Compliance Report

# Public Rights-of-Way
(Curb Ramps)

Intersection ID: 32307	**Main Street: BRIDGEVIEW_LN**	**Cross Street: NEW_PROVIDENCE_LN**	**Location:**	**SE**
ADA ID: D62485A5D91A	**Ramp Type: PerpDiag**	**Initial Pass/Fail: Fail**	**Overall Compliance: No**	**Severity Score: 25**

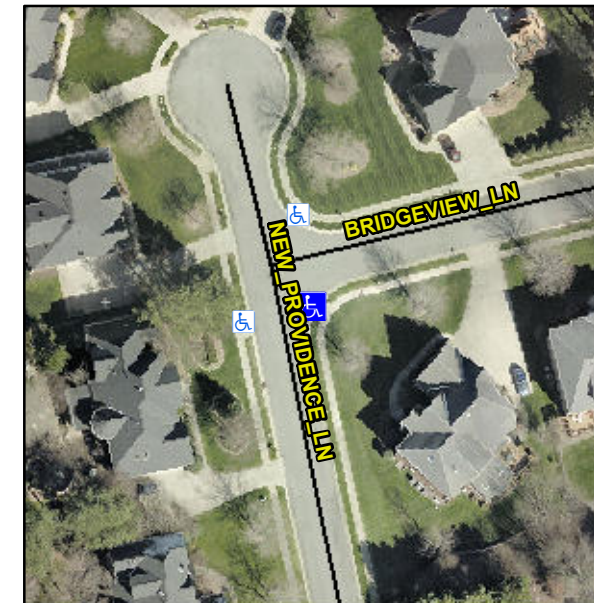
Not Found, R304.5.3

Compliance	Description	Data	Compliance	Description	Data
N/A	Ramp Length (in)	47.0	Yes	Ramp Slope (%)	5.9
Yes	Ramp Width (in)	48.0	No	Ramp XSlope (%)	9.4
N/A	Flare Type LT	N/A	N/A	Flare Type RT	N/A
N/A	Flare Slope LT (%)	N/A	N/A	Flare Slope RT (%)	N/A
N/A	Flare Traversable LT?	N/A	N/A	Flare Traversable RT?	N/A
N/A	Landing Length (in)	N/A	N/A	DWS Provided?	N/A
N/A	Landing Width (in)	N/A	N/A	DWS Contrast?	N/A
N/A	Landing Slope (%)	N/A	N/A	DWS Length (in)	N/A
N/A	Landing X Slope (%)	N/A	N/A	DWS Full Width?	N/A
N/A	Landing Curb? (Y/N)	N/A	N/A	DWS Offset (in)	N/A
N/A	Shared Landing?	N/A			
N/A	Gutter Ponding?	N/A	N/A	Gutter Slope (%)	N/A
N/A	Gutter Lip Ht (in)	N/A	N/A	Gutter X Slope (%)	N/A
N/A	Painted X Walk1?	No	N/A	Painted X Walk2?	No
	X Walk 1 Direction	To N		X Walk 2 Direction	To W
N/A	X Walk 1 Width (in)	N/A	N/A	X Walk 2 Width (in)	N/A
	X Walk 1 Slope (%)	1.8		X Walk 2 Slope (%)	5.9
	X Walk 1 X Slope (%)	5.8		X Walk 2 X Slope (%)	4.9

N/A	Ramp inside XWalk1?	N/A	N/A	Ramp inside XWalk2?	N/A
	Road Slope (%)	8.9	N/A	Clear Space?	N/A
	Road X Slope (%)	3.5	N/A	Clear Space to XWalk (in)	N/A
N/A	Any Obstructions?	N/A	N/A	Storm Grate/Utility Hazard?	N/A
	Obstruction Type			Storm Grate/Utility Type	
N/A					N/A
			Yes	Surface Condition? (G/P)	Good

Remove & Replace Curb Ramp With Two New Directional Ramps or Equivalent.
