Access Compliance Report
Public Rights-of-Way
(Curb Ramps)

Intersection ID: 23833	**Main Street: FOXRIDGE_RD**	**Cross Street: MCALPINE_FARM_RD**	**Location: SW**
ADA ID: D675D7614111	**Ramp Type: PerpDiag**	**Initial Pass/Fail: Fail**	**Overall Compliance: No** / **Severity Score: 25**

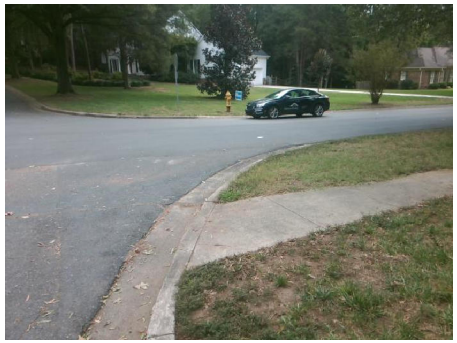
R304.2.2, R304.5.3

Compliance	Description	Data	Compliance	Description	Data
N/A	Ramp Length (in)	54.0	No	Ramp Slope (%)	8.5
Yes	Ramp Width (in)	48.0	No	Ramp XSlope (%)	5.9
N/A	Flare Type LT	N/A	N/A	Flare Type RT	N/A
N/A	Flare Slope LT (%)	N/A	N/A	Flare Slope RT (%)	N/A
N/A	Flare Traversable LT?	N/A	N/A	Flare Traversable RT?	N/A
N/A	Landing Length (in)	N/A	N/A	DWS Provided?	N/A
N/A	Landing Width (in)	N/A	N/A	DWS Contrast?	N/A
N/A	Landing Slope (%)	N/A	N/A	DWS Length (in)	N/A
N/A	Landing X Slope (%)	N/A	N/A	DWS Full Width?	N/A
N/A	Landing Curb? (Y/N)	N/A	N/A	DWS Offset (in)	N/A
N/A	Shared Landing?	N/A			
N/A	Gutter Ponding?	N/A	N/A	Gutter Slope (%)	N/A
N/A	Gutter Lip Ht (in)	N/A	N/A	Gutter X Slope (%)	N/A
N/A	Painted X Walk1?	No	N/A	Painted X Walk2?	No
	X Walk 1 Direction	To E		X Walk 2 Direction	To N
N/A	X Walk 1 Width (in)	N/A	N/A	X Walk 2 Width (in)	N/A
	X Walk 1 Slope (%)	0.5		X Walk 2 Slope (%)	7.3

X Walk 1 X Slope (%)	5.1		X Walk 2 X Slope (%)	1.8
N/A	Ramp inside XWalk1?	N/A	N/A	Ramp inside XWalk2?	N/A
	Road Slope (%)	4.3	N/A	Clear Space?	N/A
	Road X Slope (%)	4.7	N/A	Clear Space to XWalk (in)	N/A
N/A	Any Obstructions?	N/A	N/A	Storm Grate/Utility Hazard?	N/A
	Obstruction Type			Storm Grate/Utility Type	
		N/A			N/A
			Yes	Surface Condition? (G/P)	Good

Remove & Replace Curb Ramp With Two New Directional Ramps or Equivalent.
