Access Compliance Report
Public Rights-of-Way
(Curb Ramps)

Intersection ID: 15139	Main Street: EAST_BV	Cross Street: KENILWORTH_AV	Location:	W
ADA ID: D6C9FA93EE68	Ramp Type: PerpDiag	Initial Pass/Fail: Fail	Overall Compliance: No	Severity Score: 10

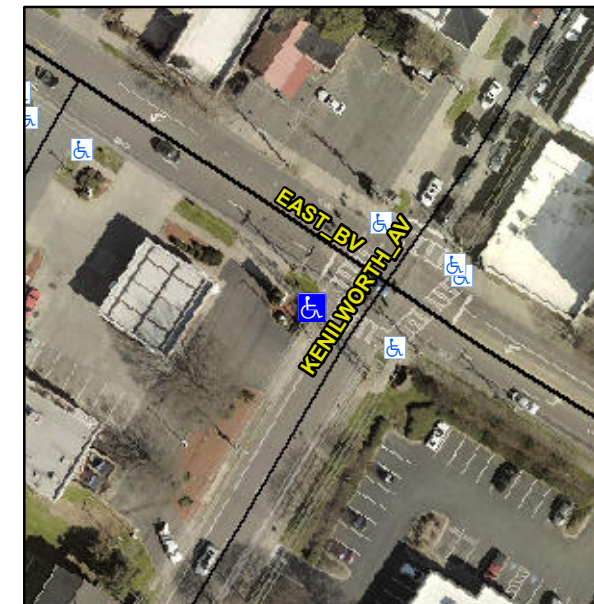
Not Found, R304.5.1

Compliance	Description	Data	Compliance	Description	Data
N/A	Ramp Length (in)	69.5	Yes	Ramp Slope (%)	6.5
No	Ramp Width (in)	43.0	Yes	Ramp XSlope (%)	3.4
N/A	Flare Type LT	N/A	N/A	Flare Type RT	N/A
N/A	Flare Slope LT (%)	N/A	N/A	Flare Slope RT (%)	N/A
N/A	Flare Traversable LT?	N/A	N/A	Flare Traversable RT?	N/A
N/A	Landing Length (in)	N/A	N/A	DWS Provided?	N/A
N/A	Landing Width (in)	N/A	N/A	DWS Contrast?	N/A
N/A	Landing Slope (%)	N/A	N/A	DWS Length (in)	N/A
N/A	Landing X Slope (%)	N/A	N/A	DWS Full Width?	N/A
N/A	Landing Curb? (Y/N)	N/A	N/A	DWS Offset (in)	N/A
N/A	Shared Landing?	N/A			
N/A	Gutter Ponding?	N/A	N/A	Gutter Slope (%)	N/A
N/A	Gutter Lip Ht (in)	N/A	N/A	Gutter X Slope (%)	N/A
N/A	Painted X Walk1?	Yes	N/A	Painted X Walk2?	Yes
	X Walk 1 Direction	To SE		X Walk 2 Direction	To NE
N/A	X Walk 1 Width (in)	110.0	N/A	X Walk 2 Width (in)	110.0
	X Walk 1 Slope (%)	0.7		X Walk 2 Slope (%)	7.0
	X Walk 1 X Slope (%)	4.3		X Walk 2 X Slope (%)	0.2

Remove & Replace Curb Ramp With Two New Directional Ramps or Equivalent.
