Access Compliance Report
Public Rights-of-Way
(Curb Ramps)

Intersection ID: 7111	Main Street: CRICKETEER_DR	Cross Street: NORTHBROOK_DR	Location:	E
ADA ID: D7A5A7CFA612	Ramp Type: Perp	Initial Pass/Fail: Fail	Overall Compliance: No	Severity Score: 37.5

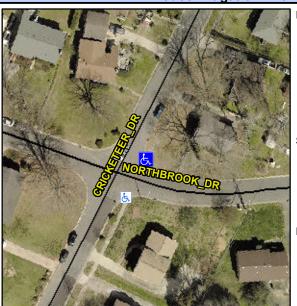
Not Found, R304.2.2, R304.5.3

Compliance	Description	Data	Compliance	Description	Data
N/A	Ramp Length (in)	25.0	No	Ramp Slope (%)	8.4
Yes	Ramp Width (in)	48.0	No	Ramp XSlope (%)	12.2
N/A	Flare Type LT	N/A	N/A	Flare Type RT	N/A
N/A	Flare Slope LT (%)	N/A	N/A	Flare Slope RT (%)	N/A
N/A	Flare Traversable LT?	N/A	N/A	Flare Traversable RT?	N/A
N/A	Landing Length (in)	N/A	N/A	DWS Provided?	N/A
N/A	Landing Width (in)	N/A	N/A	DWS Contrast?	N/A
N/A	Landing Slope (%)	N/A	N/A	DWS Length (in)	N/A
N/A	Landing X Slope (%)	N/A	N/A	DWS Full Width?	N/A
N/A	Landing Curb? (Y/N)	N/A	N/A	DWS Offset (in)	N/A
N/A	Shared Landing?	N/A			
N/A	Gutter Ponding?	N/A	N/A	Gutter Slope (%)	N/A
N/A	Gutter Lip Ht (in)	N/A	N/A	Gutter X Slope (%)	N/A
N/A	Painted X Walk1?	No	N/A	Painted X Walk2?	N/A
	X Walk 1 Direction	To SW		X Walk 2 Direction	N/A
N/A	X Walk 1 Width (in)	N/A	N/A	X Walk 2 Width (in)	N/A
	X Walk 1 Slope (%)	2.3		X Walk 2 Slope (%)	N/A
	X Walk 1 X Slope (%)	5.6		X Walk 2 X Slope (%)	N/A

Remove & Replace Entire Ramp.
