Access Compliance Report
Public Rights-of-Way
(Curb Ramps)

Intersection ID: 31668	**Main Street: EAVES_LN**	**Cross Street: TRIECE_LN**	**Location:**	**SW**
ADA ID: D8153AD88CB5	**Ramp Type: PerpDiag**	**Initial Pass/Fail: Fail**	**Overall Compliance: No**	**Severity Score: 22.5**

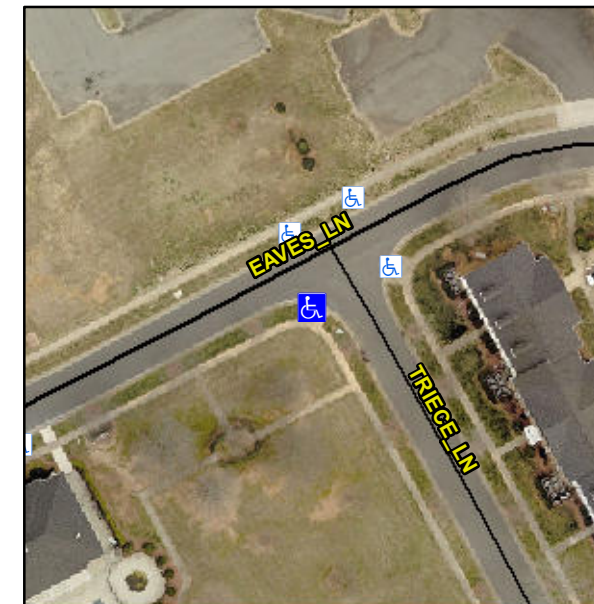
R304.5.1, R304.2.2, R304.5.3

Compliance	Description	Data	Compliance	Description	Data
N/A	Ramp Length (in)	96.0	No	Ramp Slope (%)	11.5
No	Ramp Width (in)	47.0	No	Ramp XSlope (%)	3.9
N/A	Flare Type LT	N/A	N/A	Flare Type RT	N/A
N/A	Flare Slope LT (%)	N/A	N/A	Flare Slope RT (%)	N/A
N/A	Flare Traversable LT?	N/A	N/A	Flare Traversable RT?	N/A
N/A	Landing Length (in)	N/A	N/A	DWS Provided?	N/A
N/A	Landing Width (in)	N/A	N/A	DWS Contrast?	N/A
N/A	Landing Slope (%)	N/A	N/A	DWS Length (in)	N/A
N/A	Landing X Slope (%)	N/A	N/A	DWS Full Width?	N/A
N/A	Landing Curb? (Y/N)	N/A	N/A	DWS Offset (in)	N/A
N/A	Shared Landing?	N/A			
N/A	Gutter Ponding?	N/A	N/A	Gutter Slope (%)	N/A
N/A	Gutter Lip Ht (in)	N/A	N/A	Gutter X Slope (%)	N/A
N/A	Painted X Walk1?	No	N/A	Painted X Walk2?	No
	X Walk 1 Direction	To NE		X Walk 2 Direction	To N
N/A	X Walk 1 Width (in)	N/A	N/A	X Walk 2 Width (in)	N/A
	X Walk 1 Slope (%)	0.1		X Walk 2 Slope (%)	1.9
	X Walk 1 X Slope (%)	1.7		X Walk 2 X Slope (%)	0.2

Remove & Replace Curb Ramp With Two New Directional Ramps or Equivalent.
