Access Compliance Report
Public Rights-of-Way
(Curb Ramps)

Intersection ID: 9281	Main Street: ORCHID_BLOSSOM_LN	Cross Street: WESTERWOOD_VILLAGE_DR	Location:	S
ADA ID: D9A132E1464D	Ramp Type: Perp	Initial Pass/Fail: Fail	Overall Compliance: No	Severity Score: 1.25

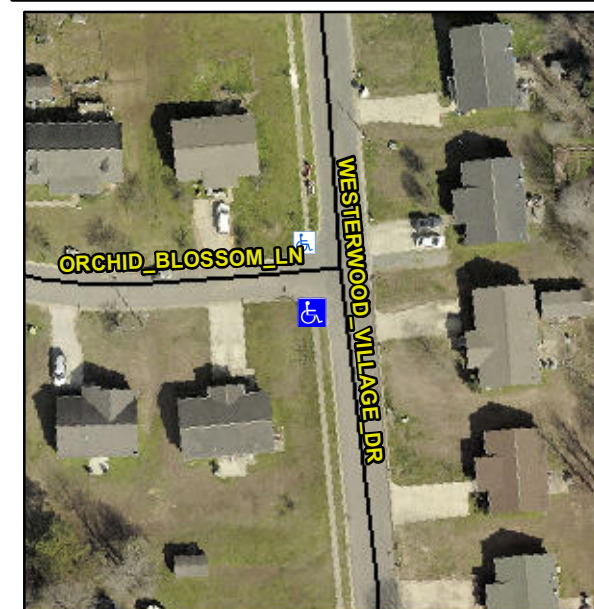
R304.5.3

Compliance	Description	Data	Compliance	Description	Data
N/A	Ramp Length (in)	37.0	Yes	Ramp Slope (%)	6.1
Yes	Ramp Width (in)	48.0	No	Ramp XSlope (%)	3.1
N/A	Flare Type LT	N/A	N/A	Flare Type RT	N/A
N/A	Flare Slope LT (%)	N/A	N/A	Flare Slope RT (%)	N/A
N/A	Flare Traversable LT?	N/A	N/A	Flare Traversable RT?	N/A
N/A	Landing Length (in)	N/A	N/A	DWS Provided?	N/A
N/A	Landing Width (in)	N/A	N/A	DWS Contrast?	N/A
N/A	Landing Slope (%)	N/A	N/A	DWS Length (in)	N/A
N/A	Landing X Slope (%)	N/A	N/A	DWS Full Width?	N/A
N/A	Landing Curb? (Y/N)	N/A	N/A	DWS Offset (in)	N/A
N/A	Shared Landing?	N/A			
N/A	Gutter Ponding?	N/A	N/A	Gutter Slope (%)	N/A
N/A	Gutter Lip Ht (in)	N/A	N/A	Gutter X Slope (%)	N/A
N/A	Painted X Walk1?	No	N/A	Painted X Walk2?	N/A
	X Walk 1 Direction	To N		X Walk 2 Direction	N/A
N/A	X Walk 1 Width (in)	N/A	N/A	X Walk 2 Width (in)	N/A
	X Walk 1 Slope (%)	3.0		X Walk 2 Slope (%)	N/A
	X Walk 1 X Slope (%)	0.6		X Walk 2 X Slope (%)	N/A

Remove & Replace Entire Ramp.
